## Annual Inspection

King Moor Parish Council

Cargo Village, Carlisle, Cumbria, CA6 4AR

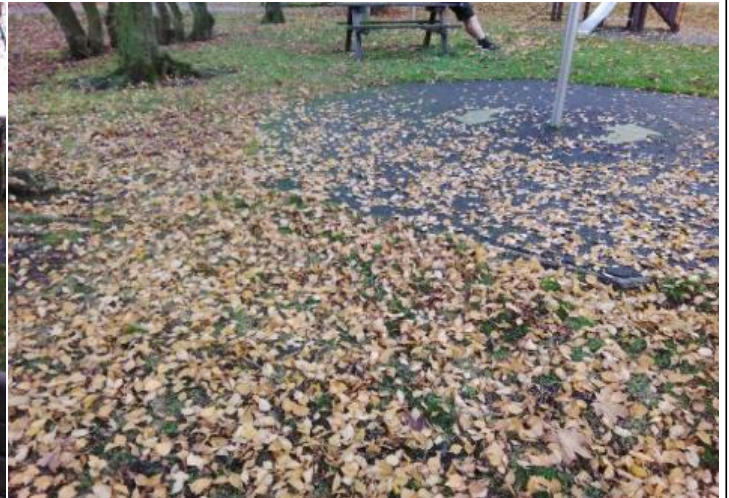
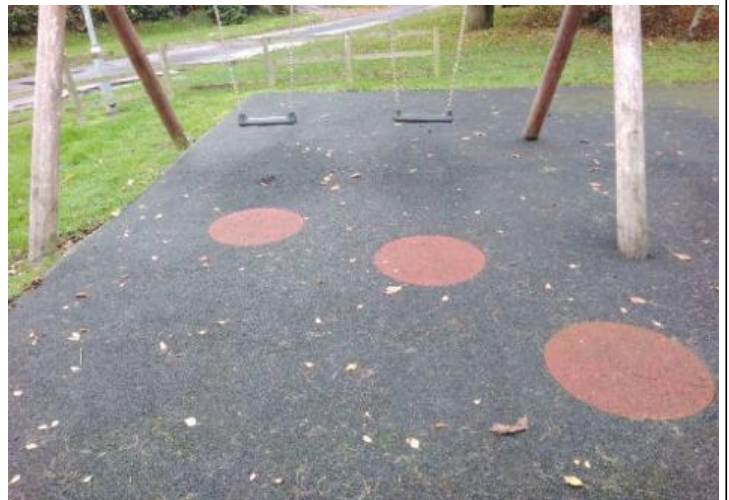
**Finding:** There is algae or moss growth on the surface resulting in slippery conditions in the majority of areas

**Action:** Clean and treat appropriately

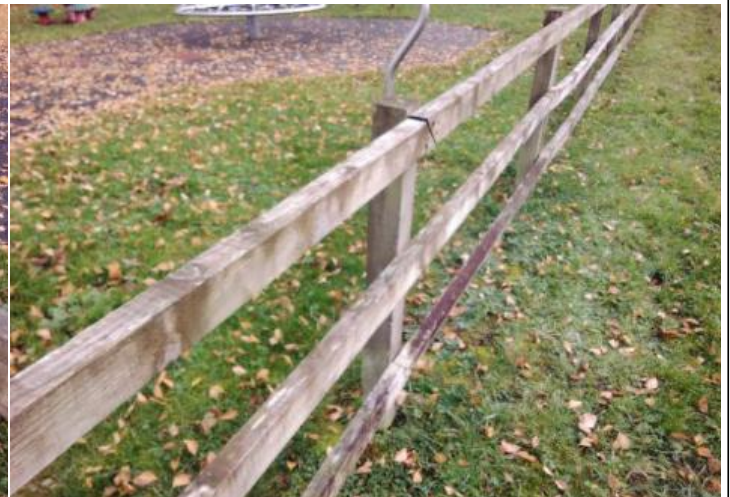
**Finding:** There are a number of loose posts around the fence

**Action:** Monitor for any further deterioration and reset as required

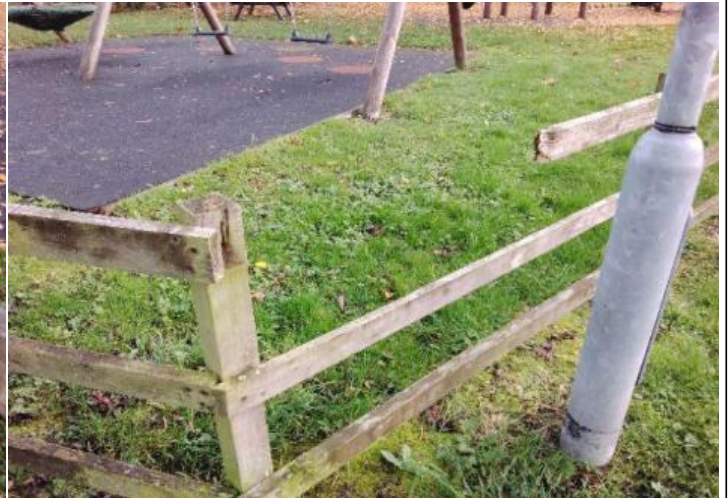
**Finding:** There is some damage to the fence sections

**Action:** Monitor for any further deterioration and repair as required

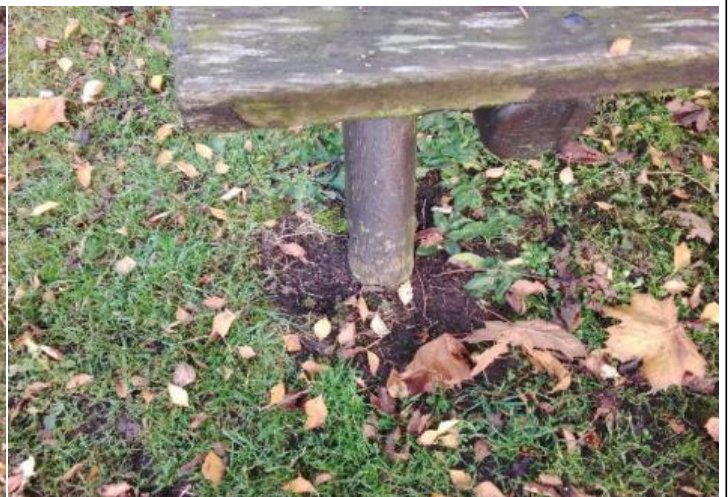
**Finding:** There is some strimmer / machinery damage apparent on the posts, this can penetrate the preservative applied to the timber and accelerate the rotting process

**Action:** Monitor for any deterioration (rot) and replace as required

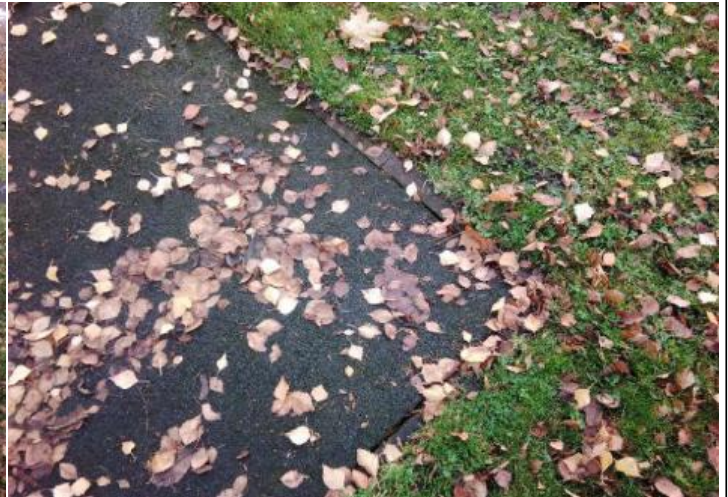
**Finding:** There are gaps opening between the surfacing and the edging surround or between the joints in the surfacing

**Action:** Monitor for any further deterioration and repair as required

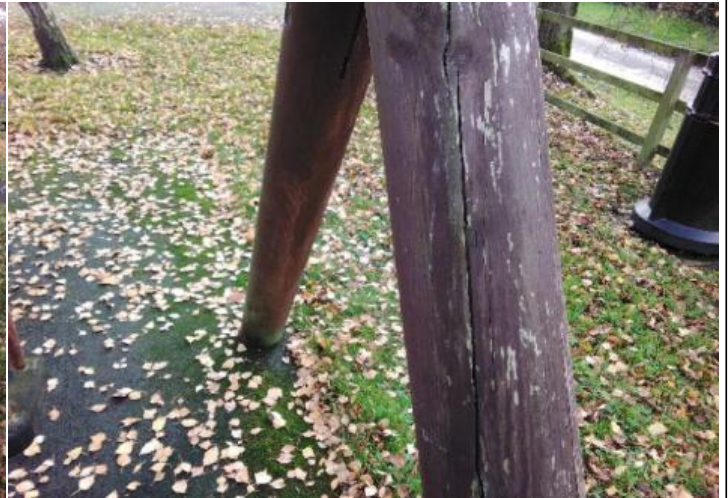
**Finding:** The timber has a number of splits/shakes or air cracks and this may affect the stability or allow water ingress which will accelerate the rotting process

**Action:** Monitor to ensure the splits do not cross through fixing points of the structure and/or cause any instability

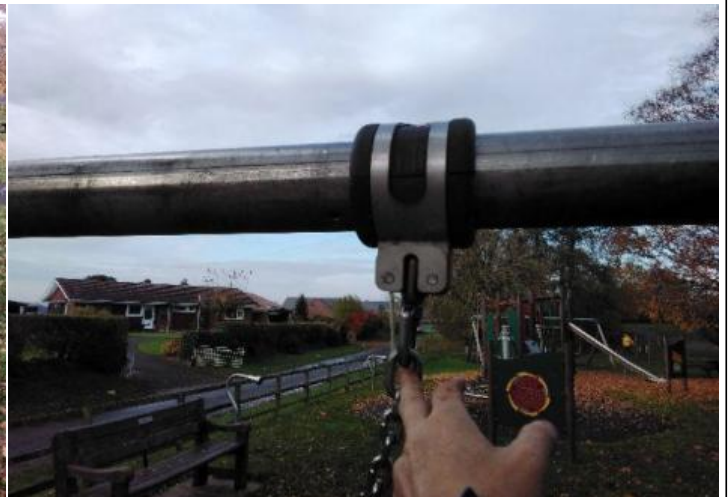
**Finding:** There is or are fixings missing on the swivel allowing the seat to slide along the cross bar

**Action:** Replace all missing fixings

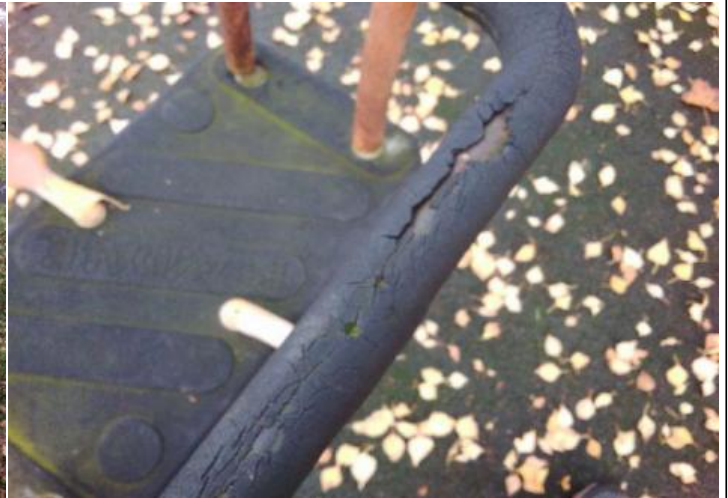
**Finding:** The seat has minor damage or wear

**Action:** Monitor for any further deterioration and replace as required

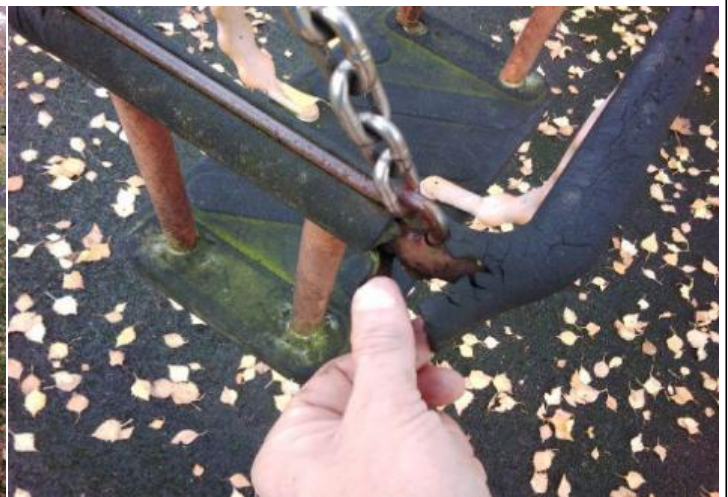
**Finding:** The swing seat frames are corroding

**Action:** Monitor for any further deterioration and replace as required

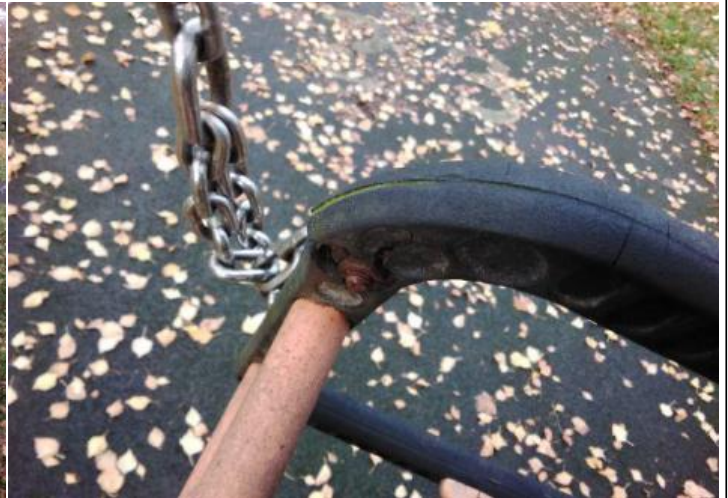
**Finding:** There are caps missing from the underside of the seats

**Action:** Replace missing caps under the seats

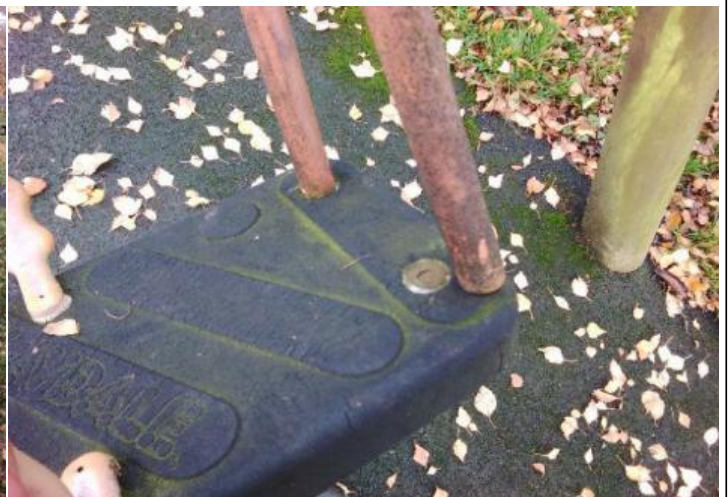
**Finding:** The seat is severely damaged and requires replacing

**Action:** Replace damaged seat

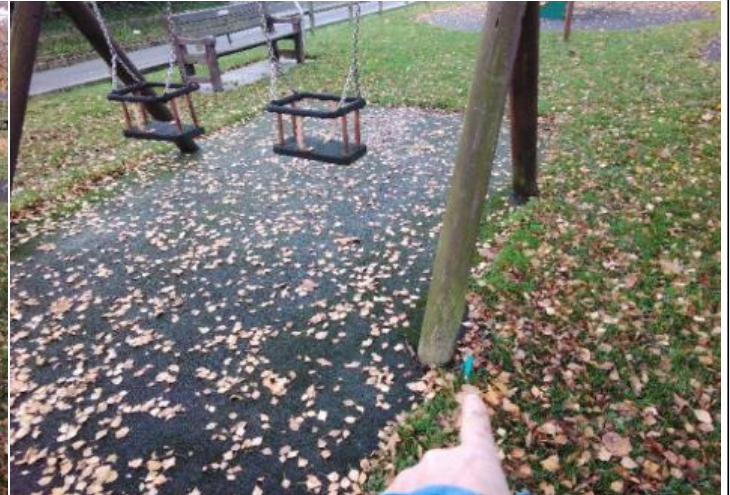
**Finding:** There are areas or parts of the timber on the structure that have rotted

**Action:** Replace all affected timbers

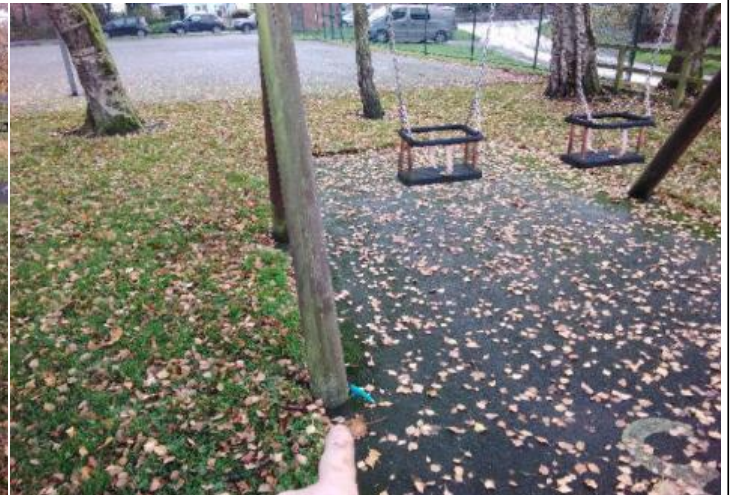
**Finding:** There are areas or parts of the timber on the structure that have rotted

**Action:** Replace all affected timbers

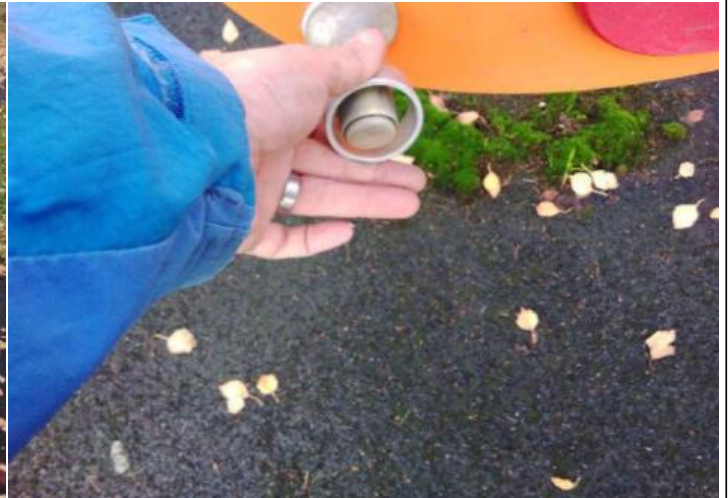
**Finding:** The end of handgrips and/or footrests have a cross section of less than 15cm<sup>2</sup> and fail to meet the requirements of BS EN 1176 Part 6  
**Action:** Monitor - No remedial work recommended

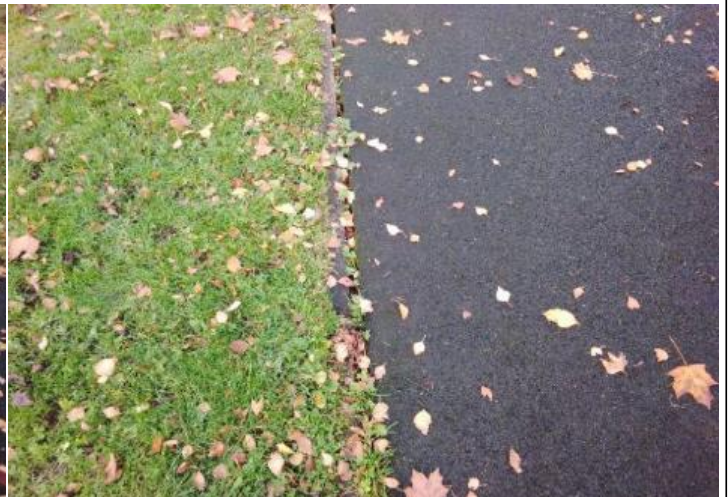
**Finding:** There are gaps opening between the surfacing and the edging surround or between the joints in the surfacing  
**Action:** Monitor for any further deterioration and repair as required

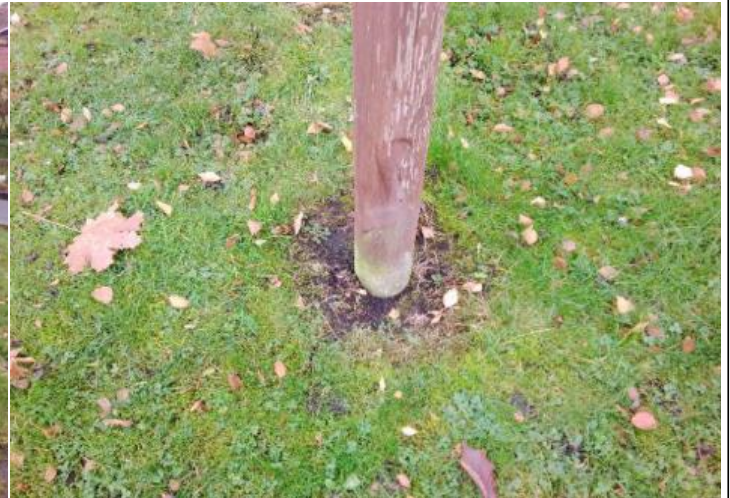
**Finding:** There is some strimmer / machinery damage apparent on the posts, this can penetrate the preservative applied to the timber and accelerate the rotting process

**Action:** Monitor for any deterioration (rot) and replace as required

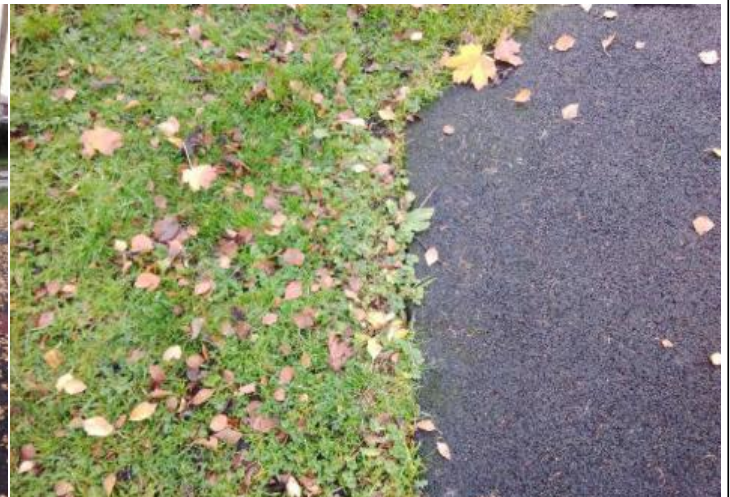
**Finding:** There are gaps opening between the surfacing and the edging surround or between the joints in the surfacing

**Action:** Monitor for any further deterioration and repair as required

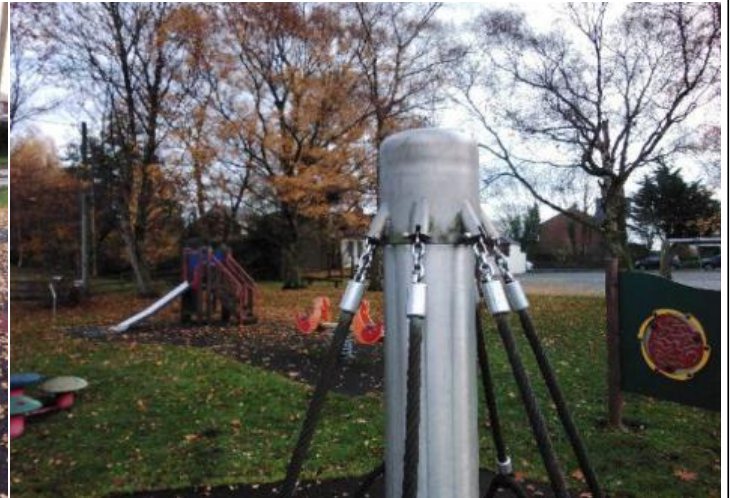
**Finding:** The bearing is showing signs of wear

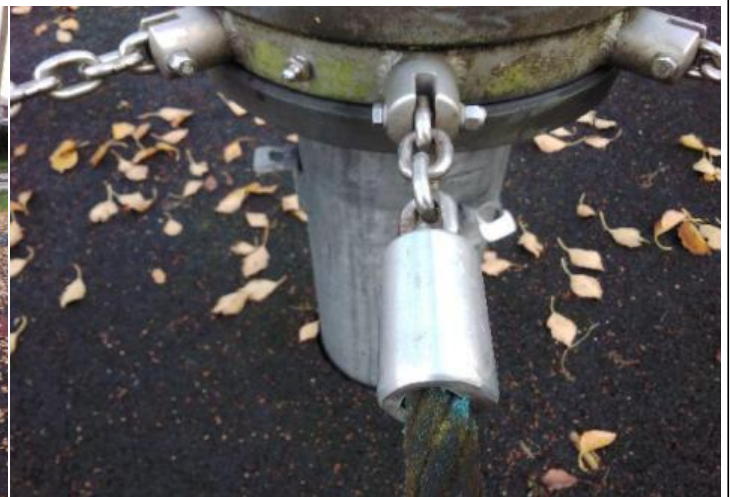
**Finding:** There appears to be components missing resulting in projecting brackets on the support

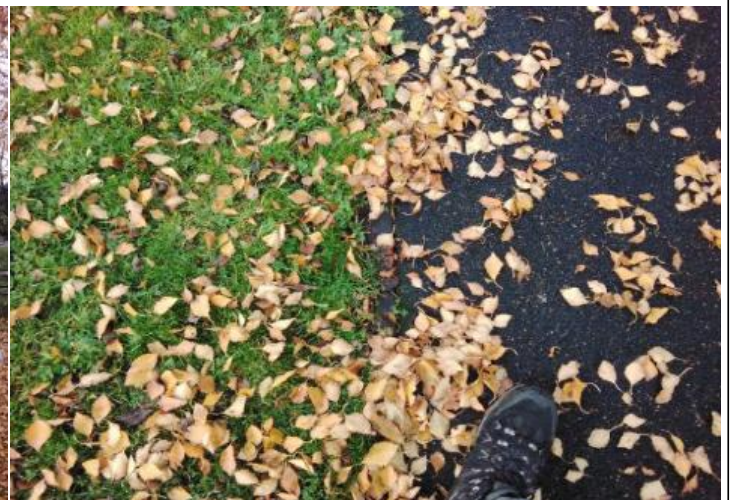
**Finding:** There are gaps opening between the surfacing and the edging surround or between the joints in the surfacing

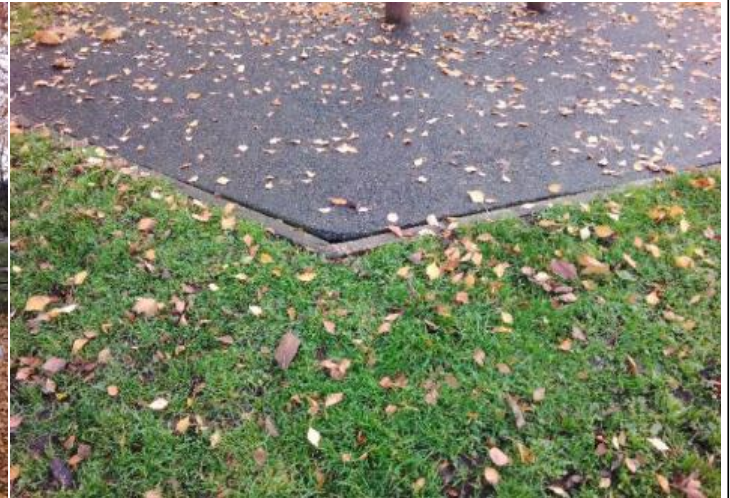
**Finding:** There are trip hazards at the edges of the surface

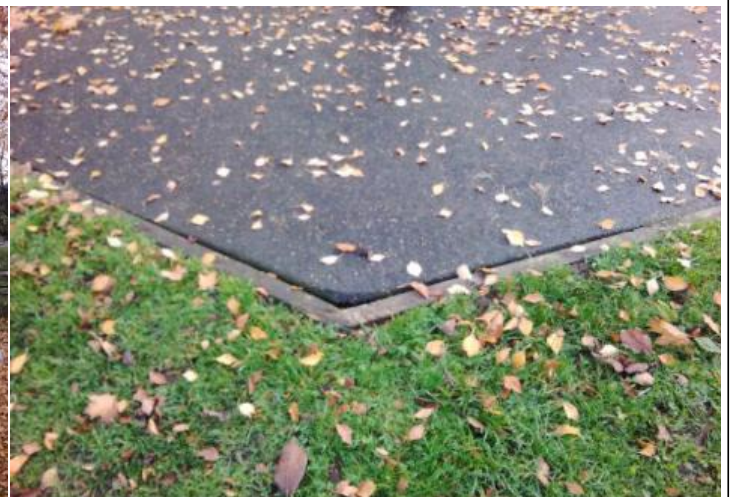
**Finding:** The surface is lifting at the edges and creating trip points

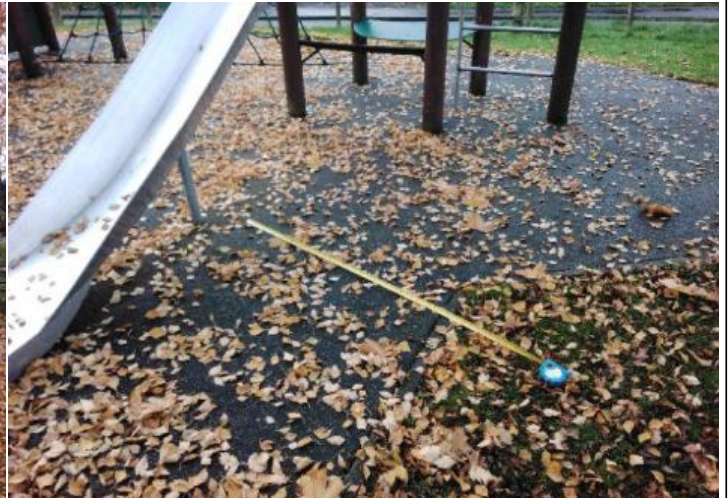
**Finding:** The surfacing dimensions are short and do not meet with the requirements of the current applicable standard

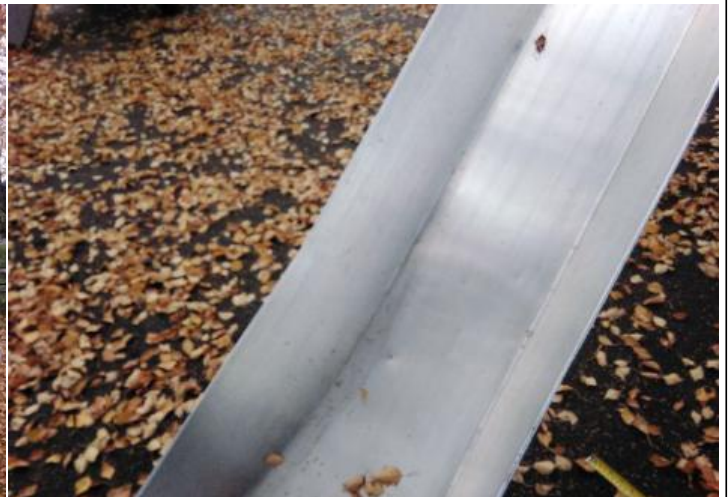
**Finding:** There are a number of dents in the slide surface

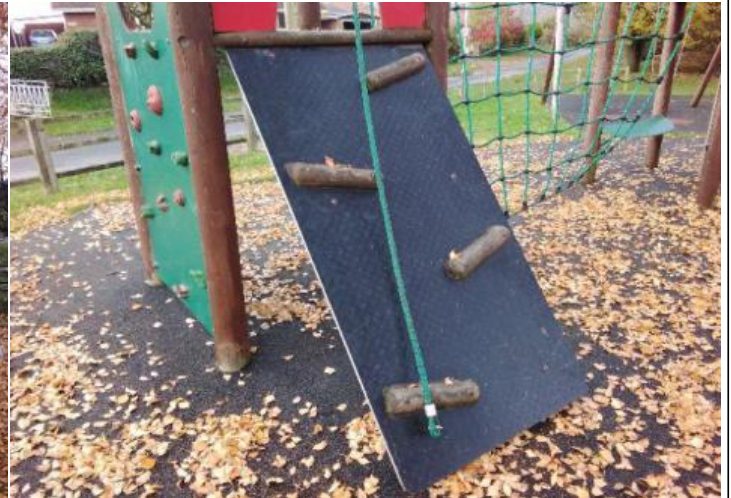
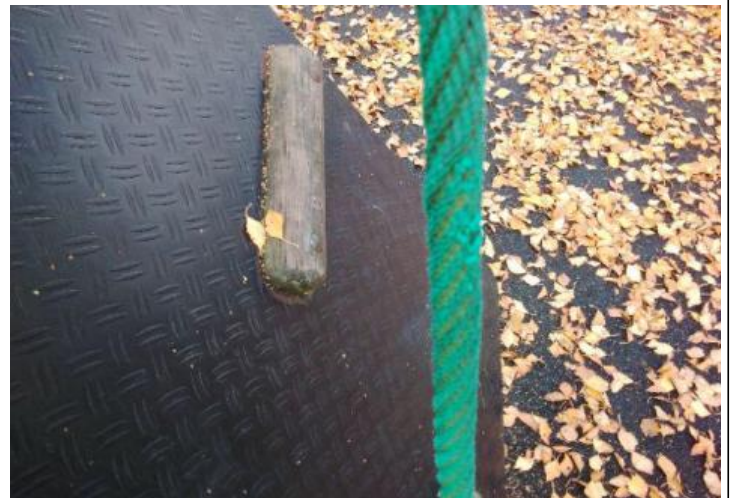
**Finding:** The ropes/nets are worn/damaged in places

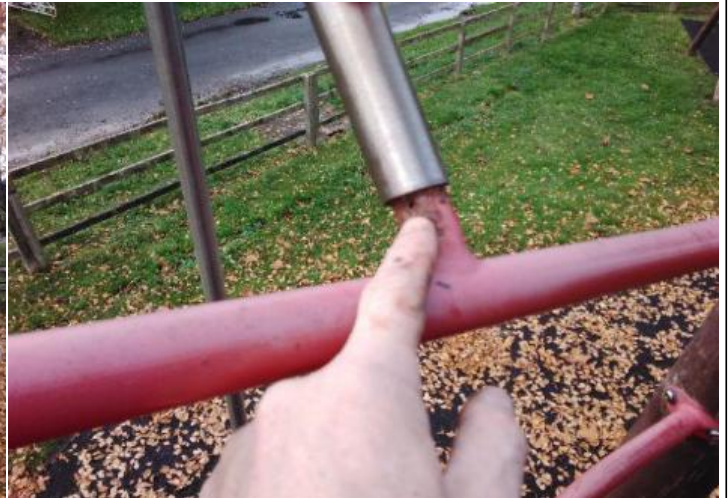
**Finding:** Parts of the steel on this item have corroded excessively and the metal has perforated in places

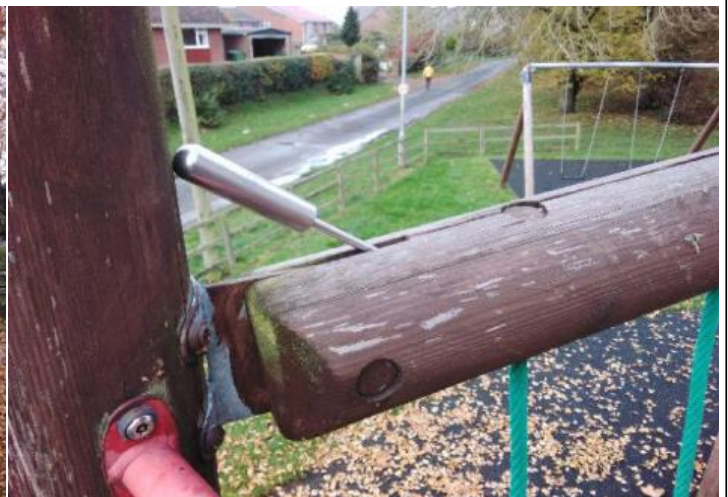
**Finding:** There is/are finger entrapment/s in the framework and the item fails to meet the requirements of BS EN 1176 Part 1 4.2.7.6 Entrapment of fingers

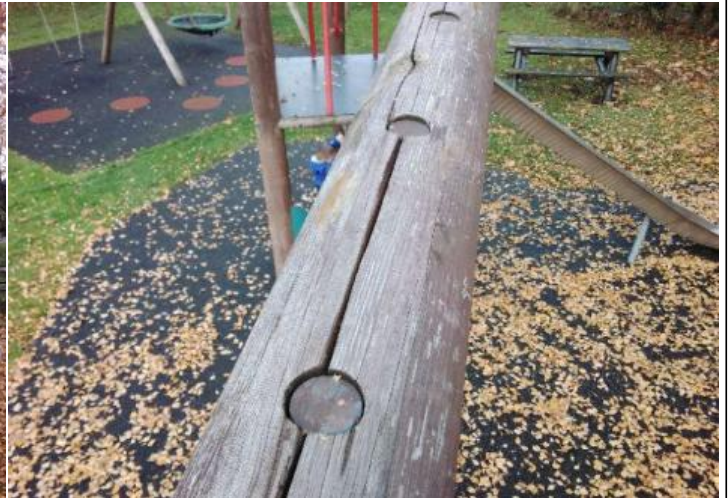
**Finding:** The timber has a number of splits/shakes or air cracks and this may affect the stability or allow water ingress which will accelerate the rotting process

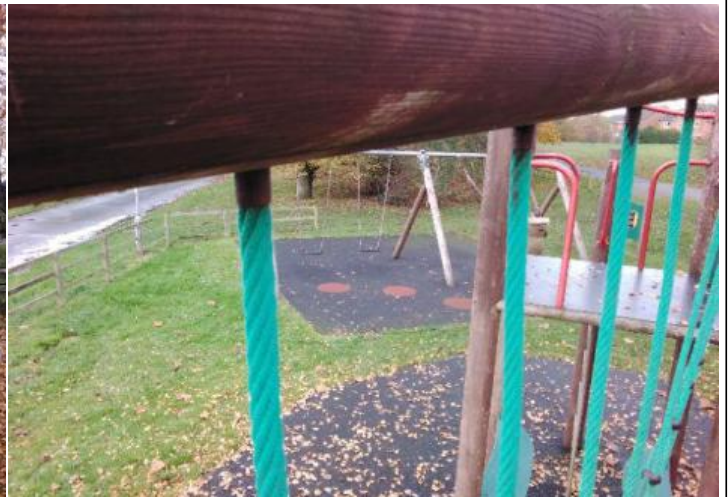
**Finding:** Rope ferrules are corroding on the scramble net

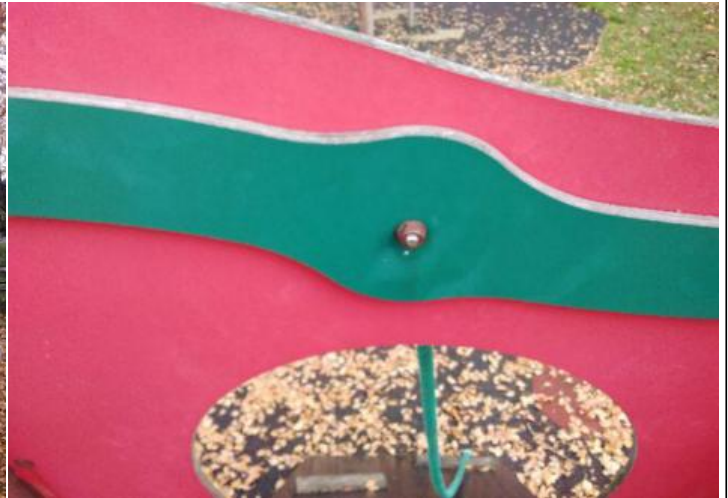
**Finding:** There is/are bolt cap covers missing or damaged on the item

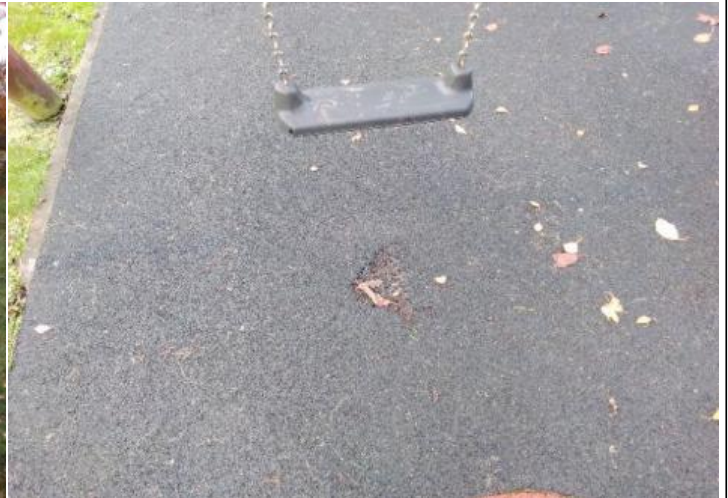
**Finding:** The safety surface under or around this unit has been damaged

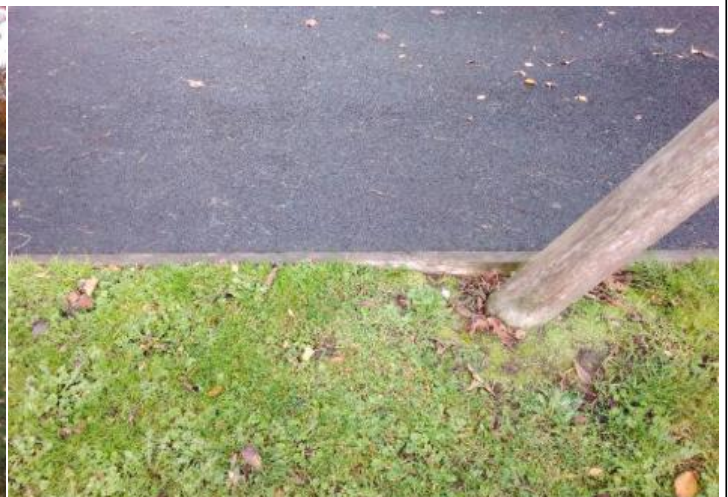
**Finding:** There are trip hazards at the edges of the surface

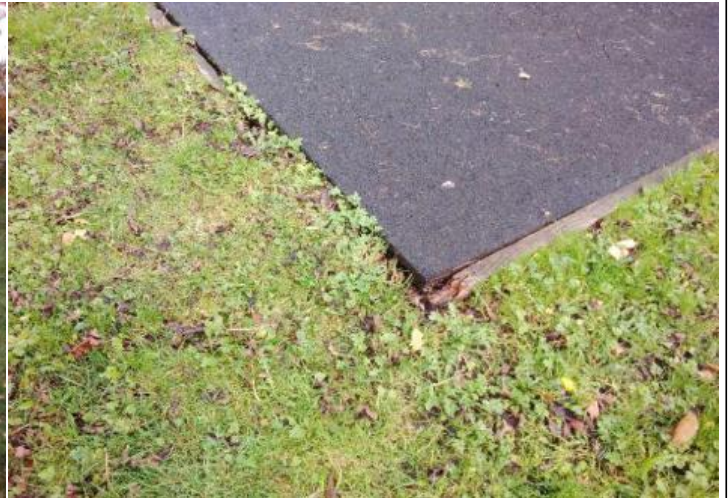
**Finding:** The timber edge has rotted

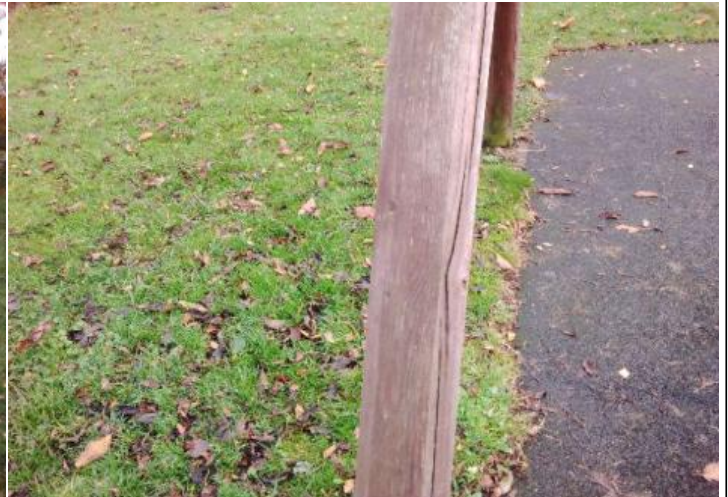
**Finding:** The timber has a number of splits/shakes or air cracks and this may affect the stability or allow water ingress which will accelerate the rotting process

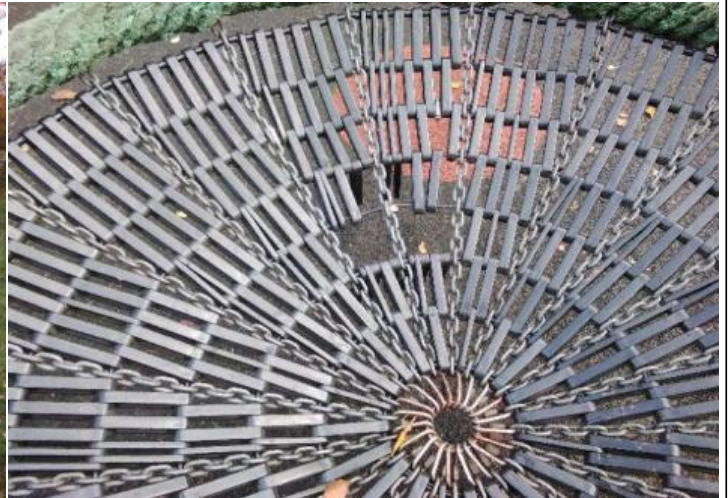
**Finding:** The seat is severely damaged and requires replacing

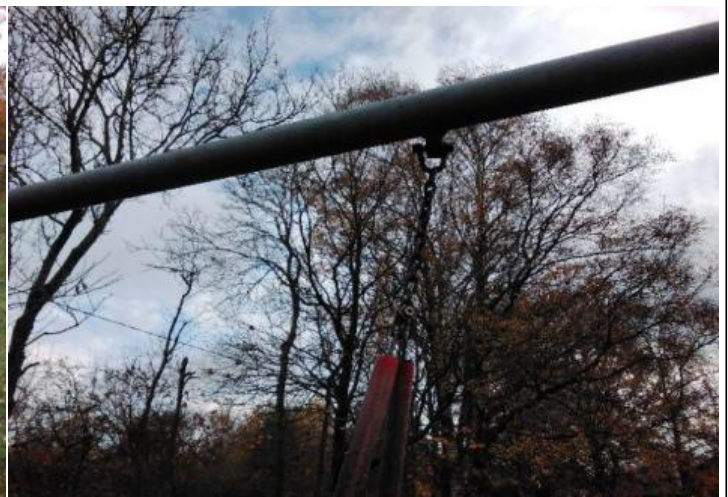
**Finding:** Swings of this design should have a secondary safety device fitted to prevent collapse of the seat in the event of a joint failure to meet the requirements of BS EN 1176 Part 2

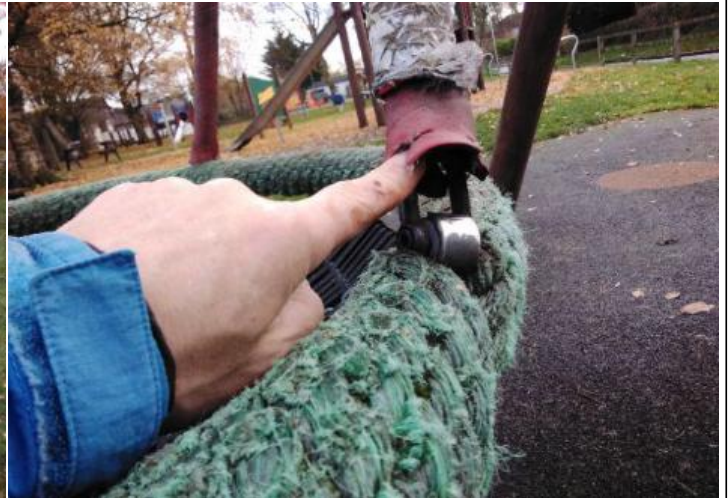
**Finding:** The bushes are worn or missing

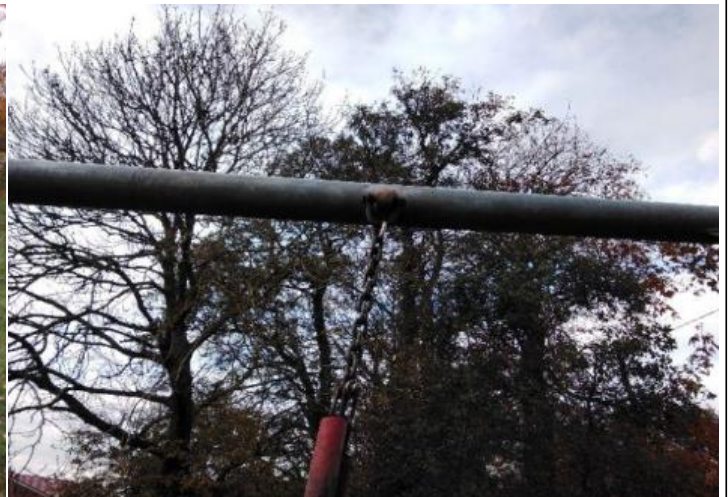
**Finding:** The shackles are worn in excess of 40% and require renewing, raised risk as no safety chain

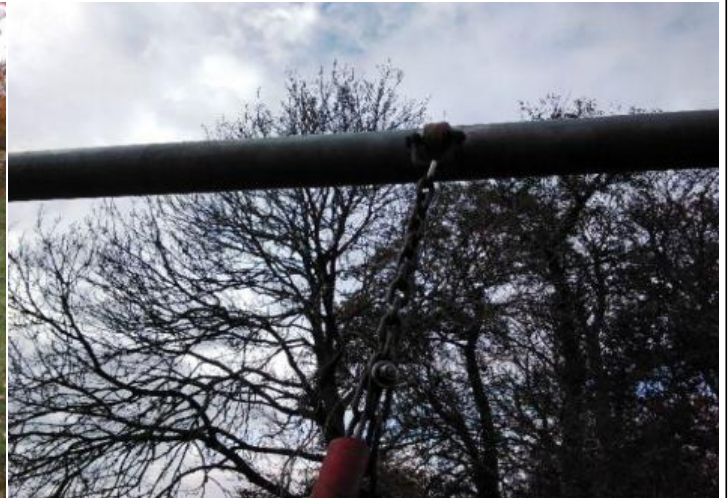
**Finding:** The bushes are showing signs of wear

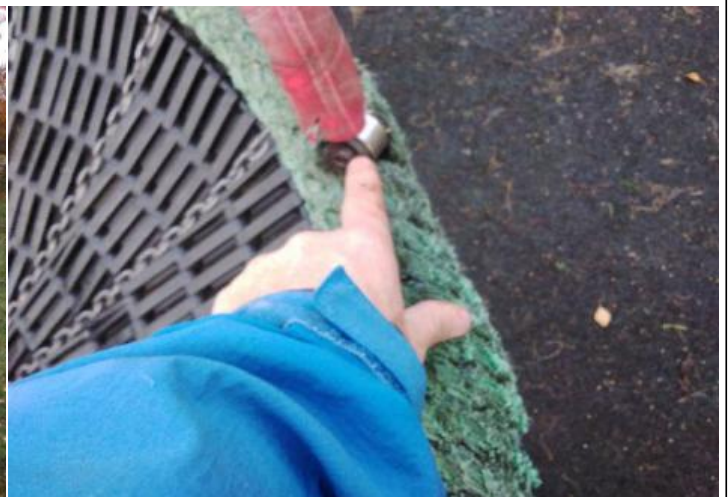
**Finding:** The bushes are showing signs of wear

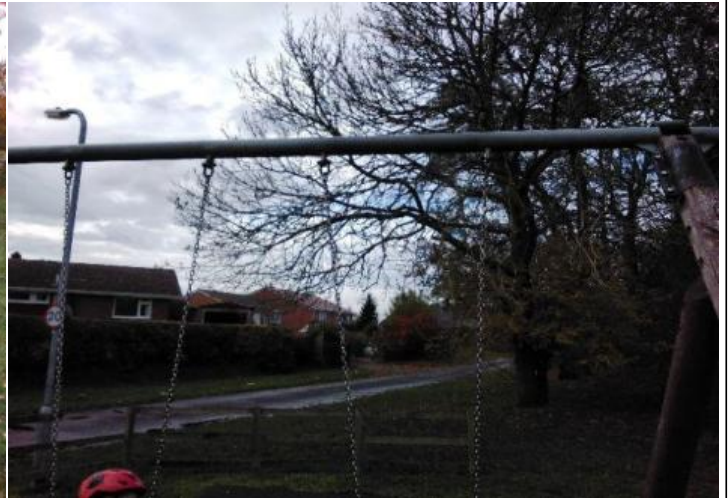
**Finding:** There is some wear to the shackles.

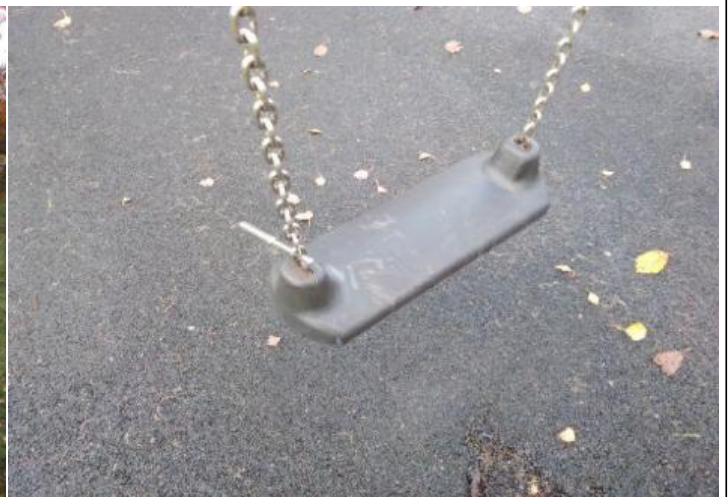
**Finding:** The chain openings are in excess of the 8.6mm as recommended by BS EN 1176

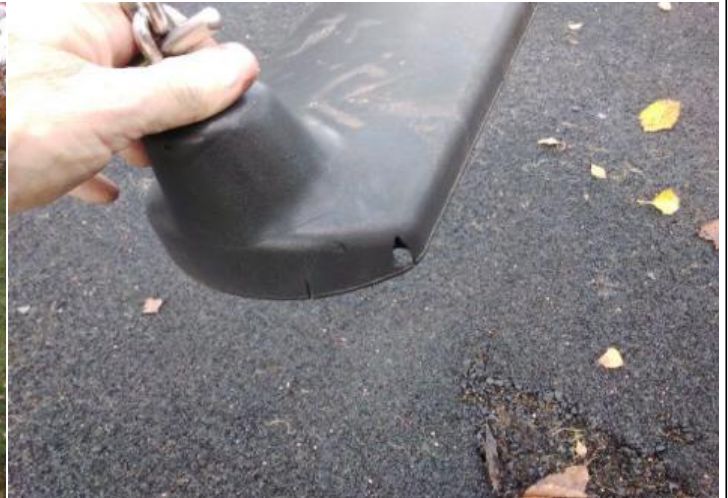
**Finding:** The seat has minor damage or wear

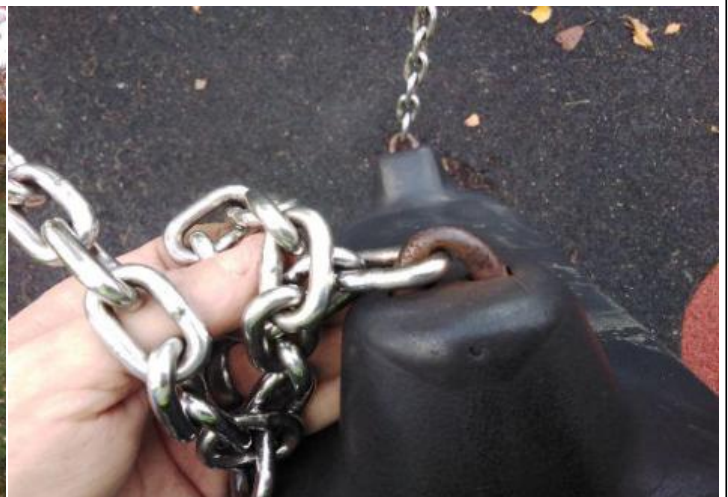
**Finding:** There is wear to the swing seat lugs

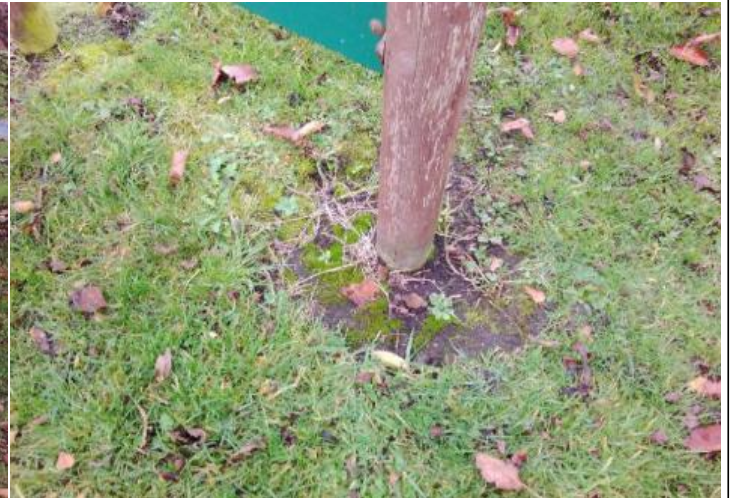
**Finding:** There is some strimmer / machinery damage apparent on the posts, this can penetrate the preservative applied to the timber and accelerate the rotting process

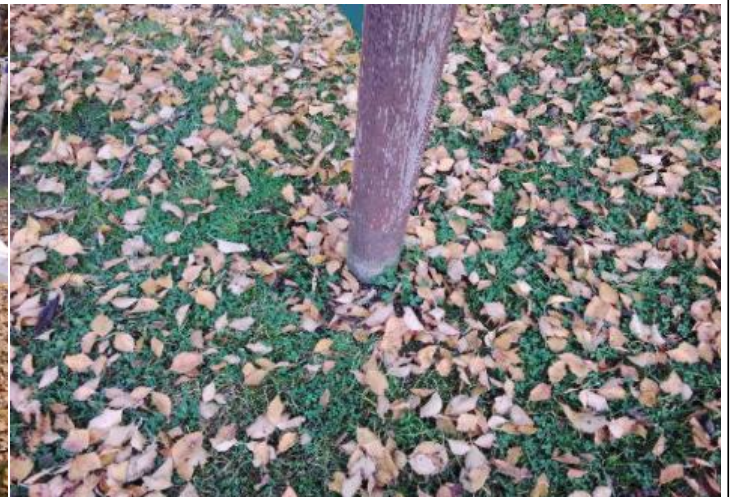
**Finding:** There is some strimmer / machinery damage apparent on the posts, this can penetrate the preservative applied to the timber and accelerate the rotting process

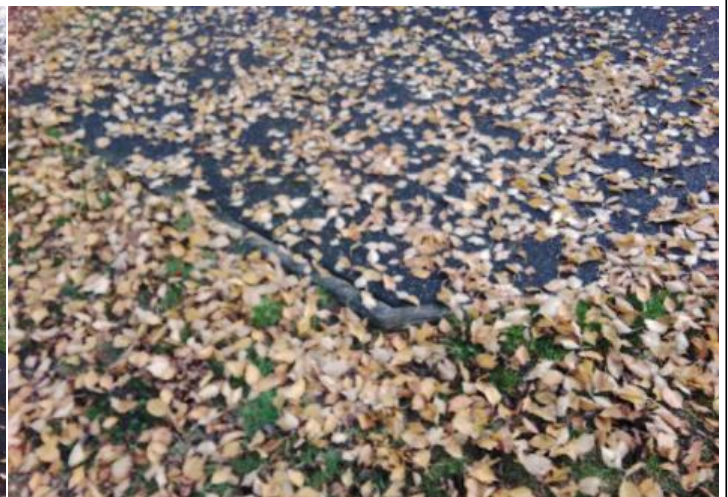
**Finding:** There are trip hazards at the edges of the surface

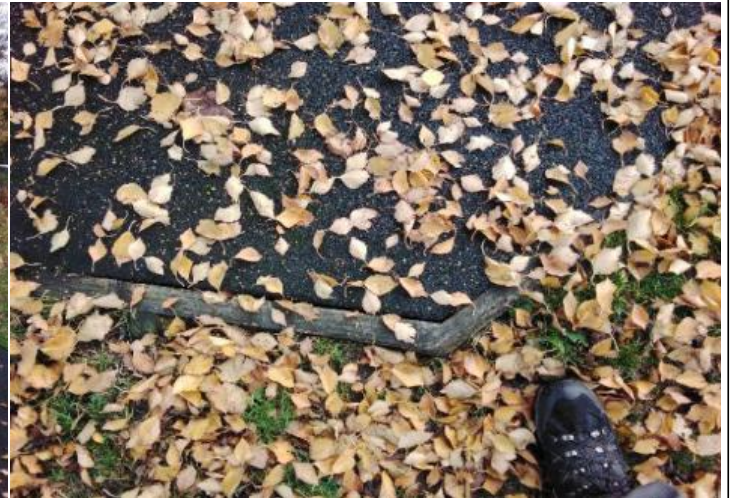
**Finding:** There are gaps opening between the surfacing and the edging surround or between the joints in the surfacing  
**Action:** Monitor for any further deterioration and repair as required

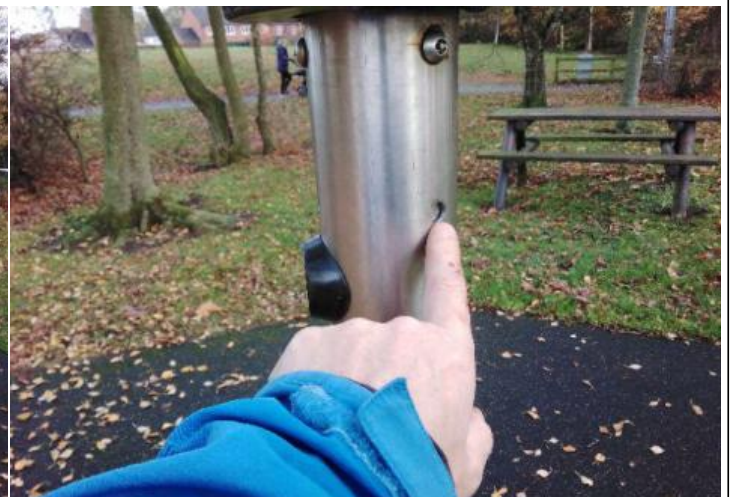
**Finding:** It appears that there are fixings missing  
**Action:** Refer to manufacturer as to correct fitment

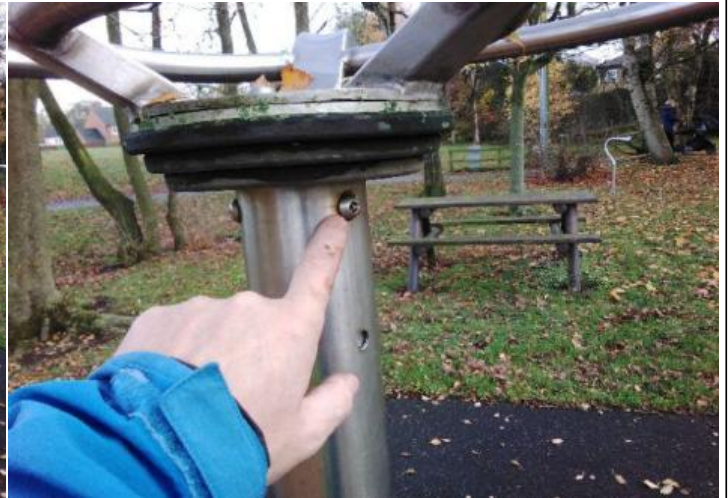
**Finding:** A number of fixing(s) have worked loose

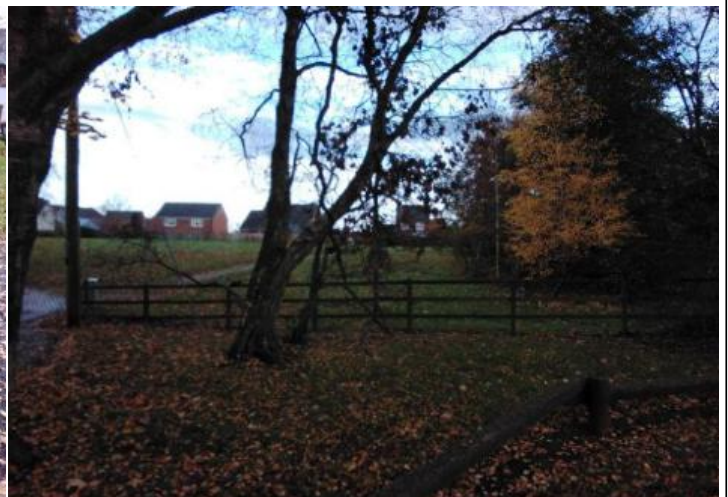
**Finding:** A damaged branch is hanging in in the fall space

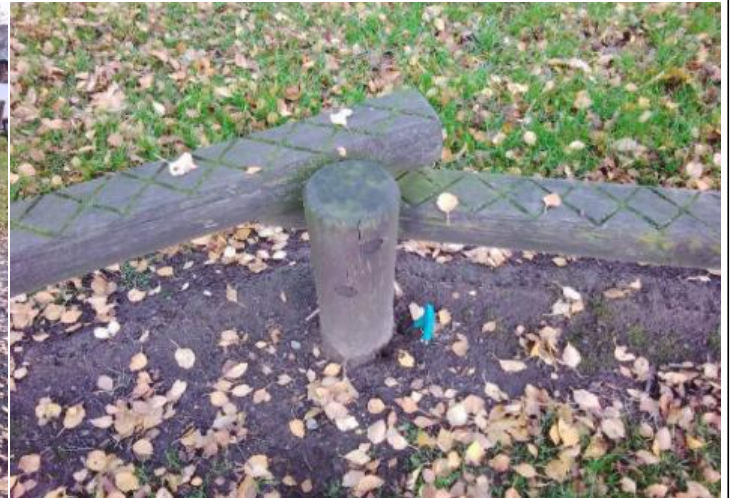
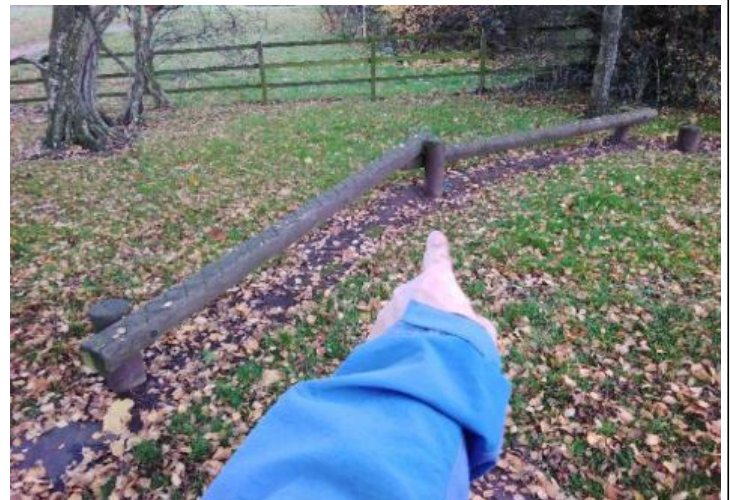
**Finding:** There are areas or parts of the timber on the structure that have rotted

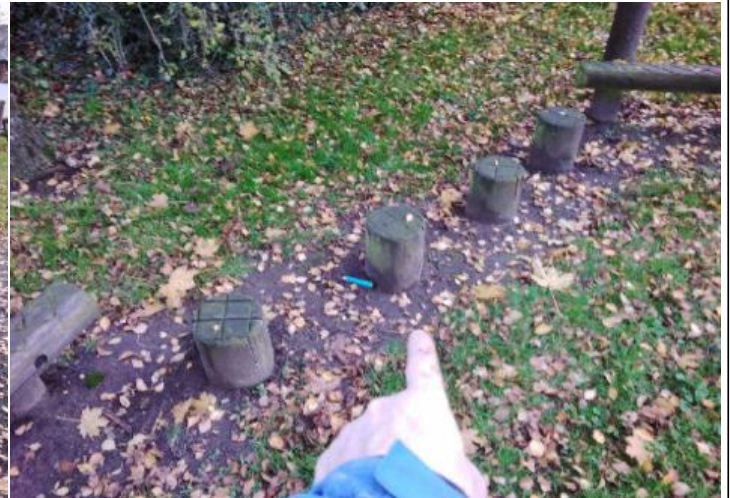
**Finding:** There are areas or parts of the timber on the structure that have rotted

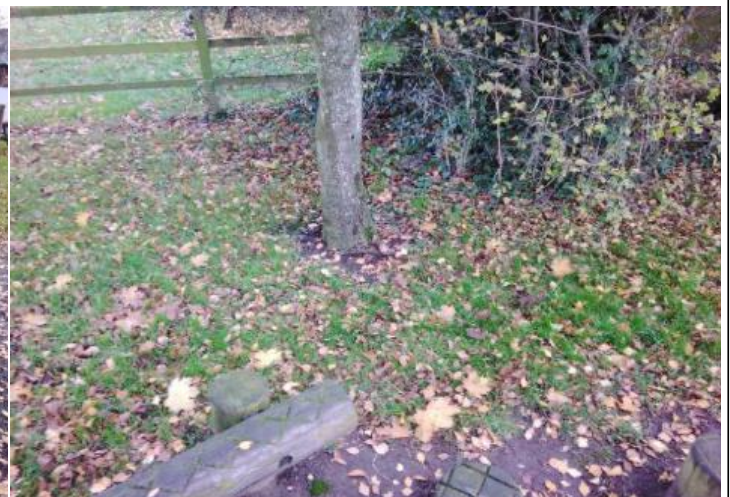
**Finding:** The adjacent tree trunk forms a hard object within the falling space of the equipment in contravention of the requirements of BS EN 1176 Part 1

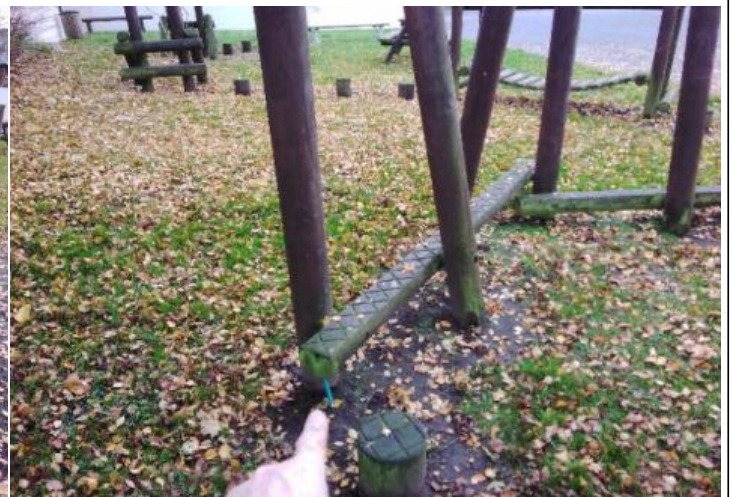
**Finding:** There are areas or parts of the timber on the structure that have rotted

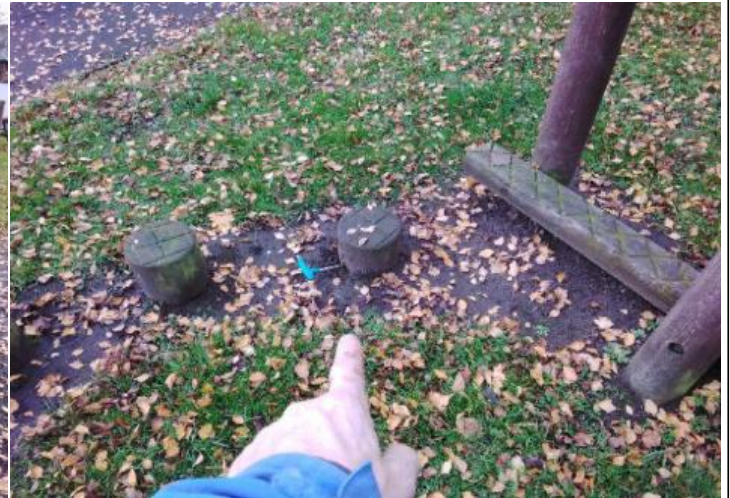
**Finding:** There are areas or parts of the timber on the structure that have rotted
