## Annual Inspection

King Moor Parish Council

Cargo Village, Carlisle, Cumbria, CA6 4AR

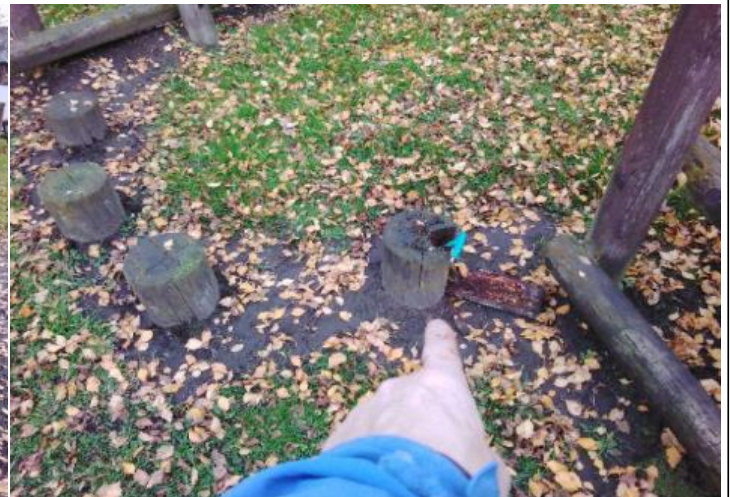
**Finding:** The timber on this item has severe rot

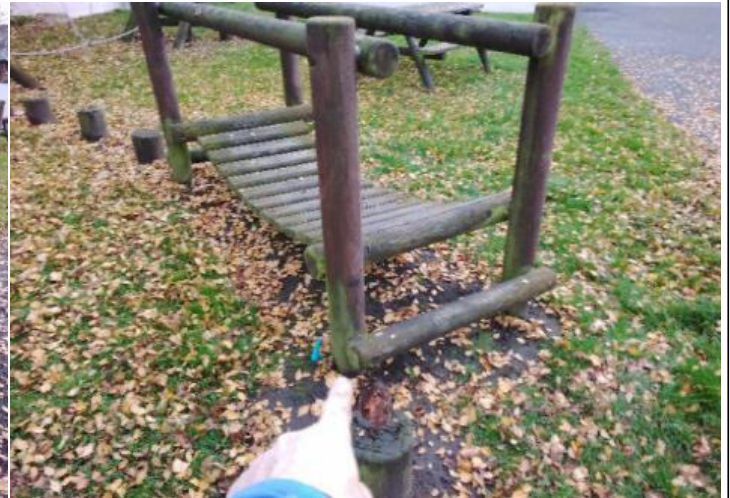
**Finding:** There are areas or parts of the timber on the structure that have rotted

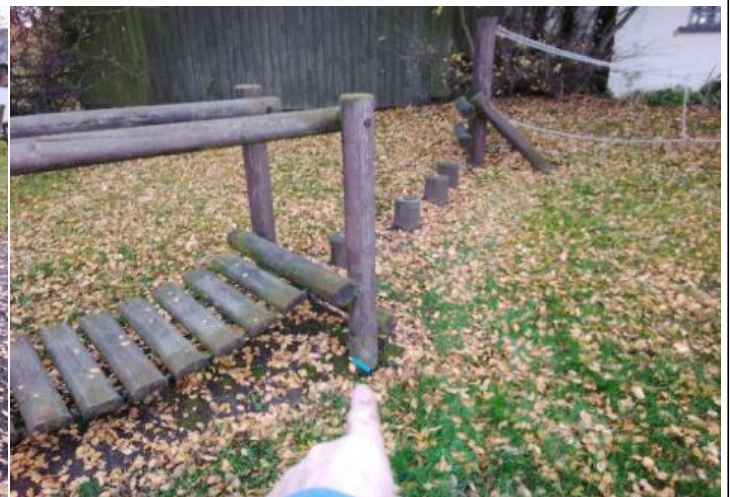
**Finding:** There are areas or parts of the timber on the structure that have rotted

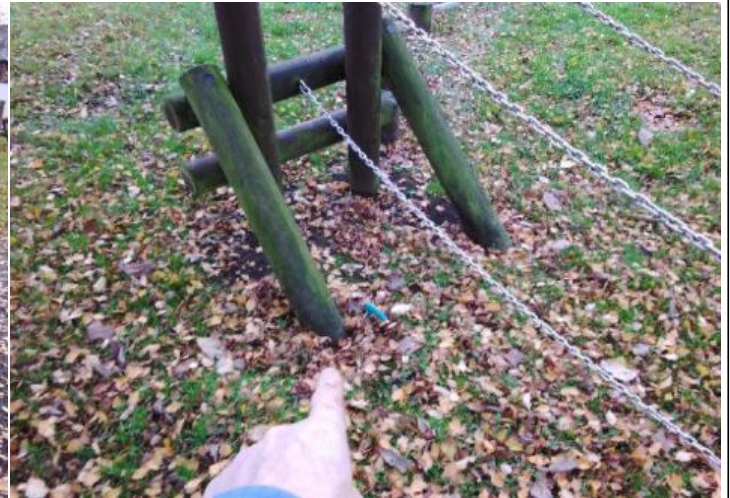
**Finding:** There are areas or parts of the timber on the structure that have rotted

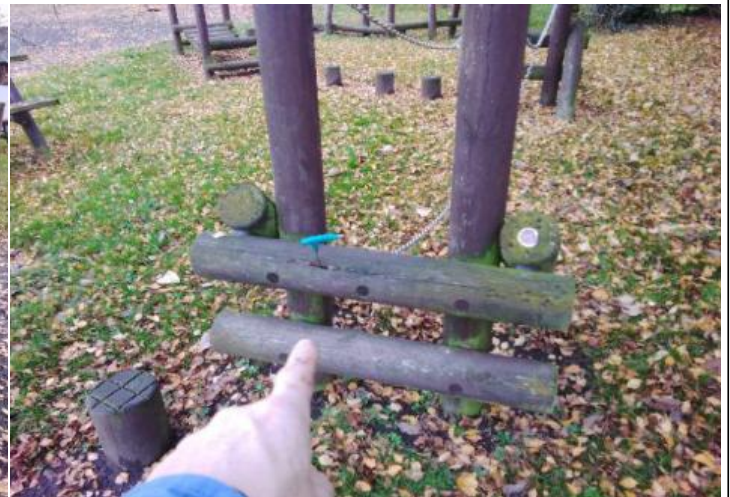
**Finding:** The timber on this item has severe rot

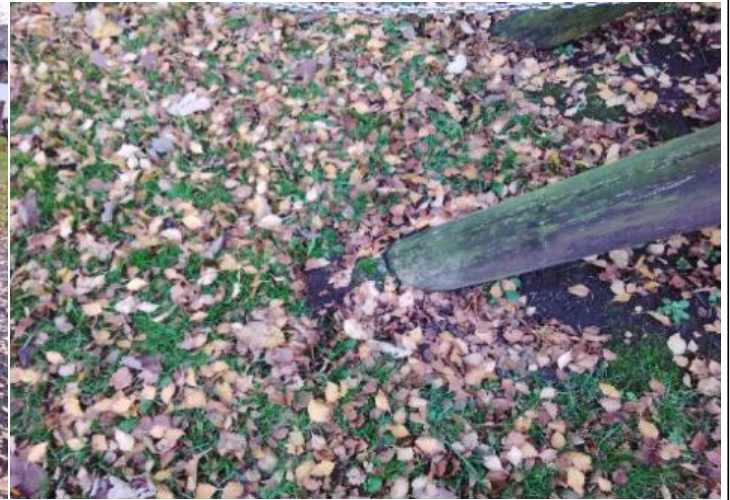
**Finding:** The surface has eroded and the foundations are exposed

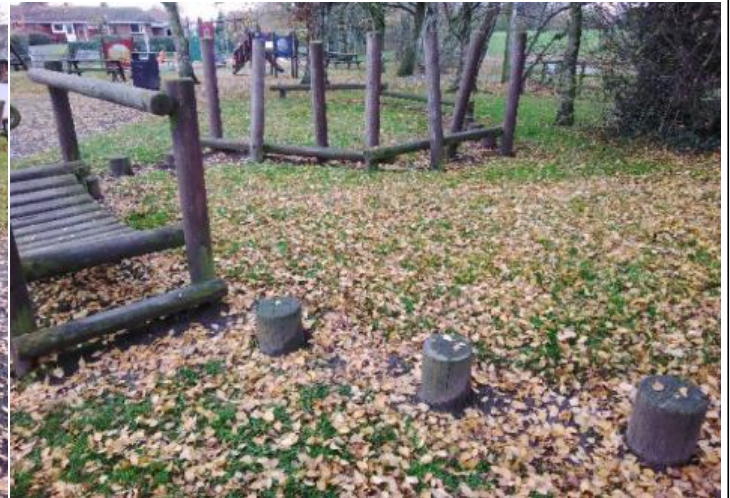
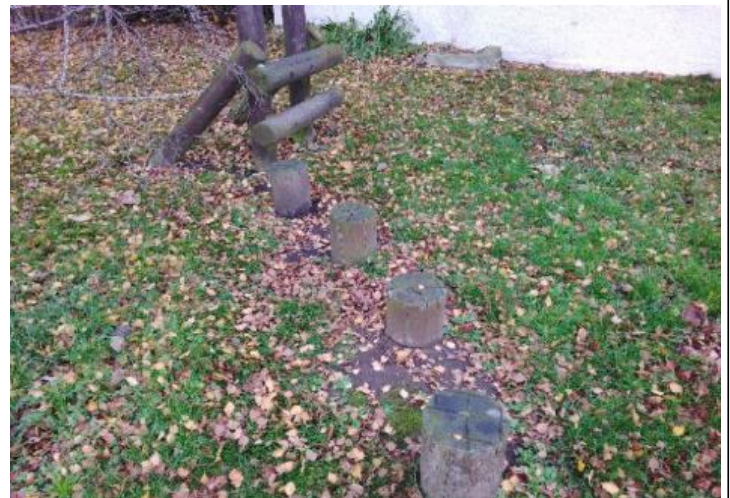
**Finding:** There is some evidence of rot in all the timber element supports

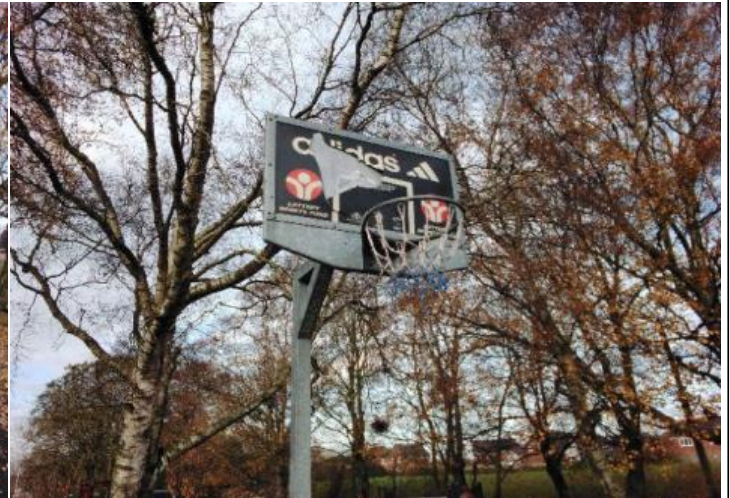
**Finding:** The backboard is damaged

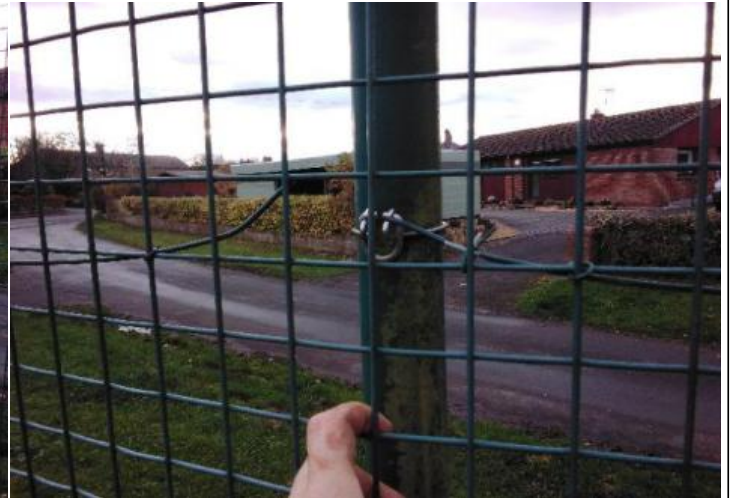
**Finding:** The fence mesh is loose on the posts in areas

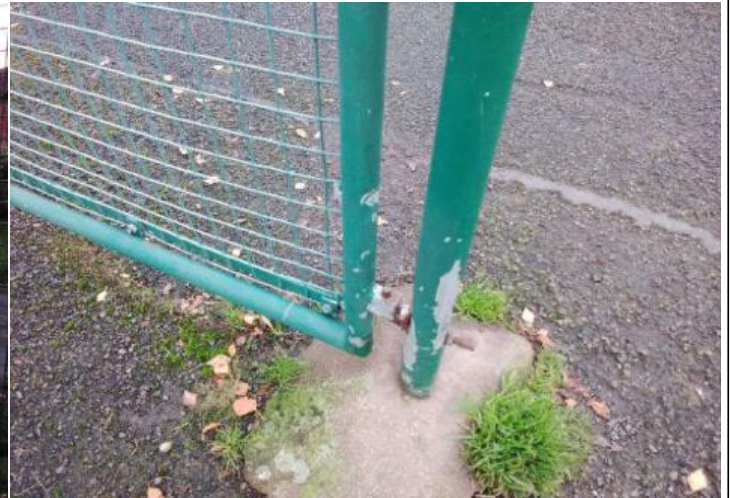
**Finding:** The gate is loose on its hinges
