## Annual Inspection

King Moor Parish Council

Cargo Village, Carlisle, Cumbria, CA6 4AR

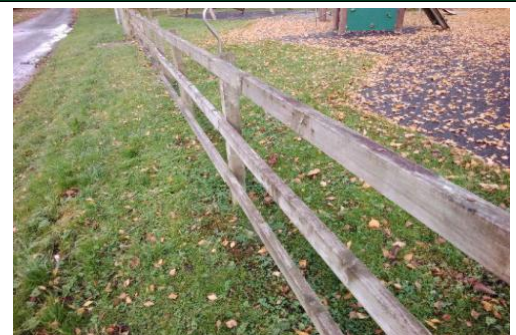
**Item:** Fencing - Post & Rail  
**Manufacturer:** Owner/Operator  
**Surface Type:** Grass  
**Item Quantity:** 1  
**Equipment Compliance:** N/A  
**Surface Area Compliance:** N/A

There are a number of loose posts around the fence - Monitor for any further deterioration and reset as required

There is some damage to the fence sections - Monitor for any further deterioration and repair as required

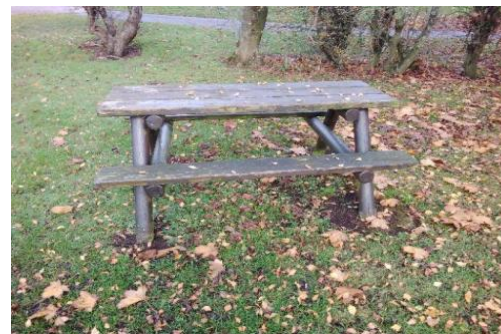
**Item:** Picnic Table  
**Manufacturer:** Owner/Operator  
**Surface Type:** Grass  
**Item Quantity:** 4  
**Equipment Compliance:** N/A  
**Surface Area Compliance:** N/A

There is some strimmer / machinery damage apparent on the posts, this can penetrate the preservative applied to the timber and accelerate the rotting process - Monitor for any deterioration (rot) and replace as required

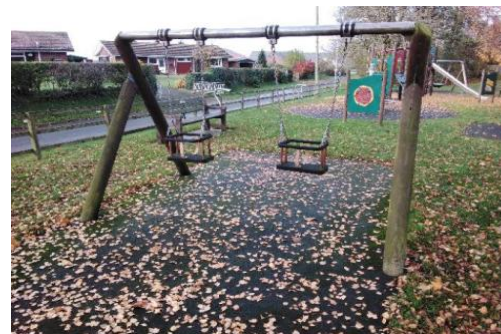
**Item:** 1 Bay 2 Seat (Cradle)  
**Manufacturer:** Playdale Playgrounds Ltd  
**Surface Type:** Wet Pour  
**Item Quantity:** 1  
**Equipment Compliance:** Yes  
**Surface Area Compliance:** Yes

There are gaps opening between the surfacing and the edging surround or between the joints in the surfacing - Monitor for any further deterioration and repair as required

There is or are fixings missing on the swivel allowing the seat to slide along the cross bar - Replace all missing fixings

The swing seat frames are corroding - Monitor for any further deterioration and replace as required

The seat is severely damaged and requires replacing - Replace damaged seat

There are areas or parts of the timber on the structure that have rotted - Replace all affected timbers

The timber has a number of splits/shakes or air cracks and this may affect the stability or allow water ingress which will accelerate the rotting process - Monitor to ensure the splits do not cross through fixing points of the structure and/or cause any instability

The seat has minor damage or wear - Monitor for any further deterioration and replace as required

There are caps missing from the underside of the seats - Replace missing caps under the seats

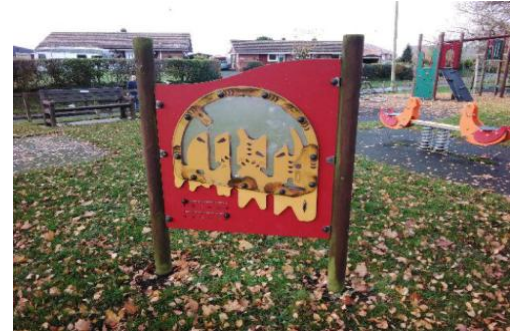
**Item:** Play Panel  
**Manufacturer:** Playdale Playgrounds Ltd  
**Surface Type:** Grass  
**Item Quantity:** 1  
**Equipment Compliance:** Yes  
**Surface Area Compliance:** N/A

There is some strimmer / machinery damage apparent on the posts, this can penetrate the preservative applied to the timber and accelerate the rotting process - Monitor for any deterioration (rot) and replace as required

There is/are bolt cap covers missing or damaged on the item - Replace missing or damaged bolt cap covers

The lever cap is missing - Replace lever cap

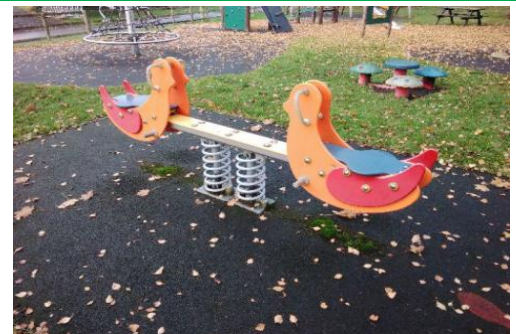
**Item:** Spring See-Saw  
**Manufacturer:** Playdale Playgrounds Ltd  
**Surface Type:** Wet Pour  
**Item Quantity:** 1  
**Equipment Compliance:** No  
**Surface Area Compliance:** Yes

The end of handgrips and/or footrests have a cross section of less than 15cm<sup>2</sup> and fail to meet the requirements of BS EN 1176 Part 6 - Monitor - No remedial work recommended

There are gaps opening between the surfacing and the edging surround or between the joints in the surfacing - Monitor for any further deterioration and repair as required

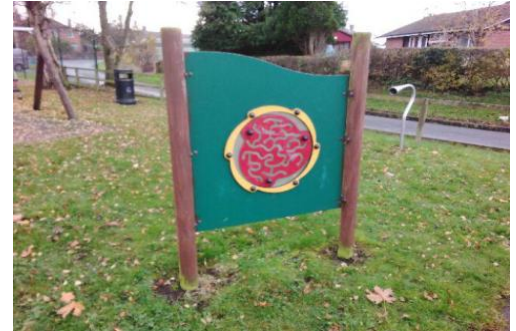
**Item:** Play Panel  
**Manufacturer:** Playdale Playgrounds Ltd  
**Surface Type:** Grass  
**Item Quantity:** 1  
**Equipment Compliance:** Yes  
**Surface Area Compliance:** N/A

There is some strimmer / machinery damage apparent on the posts, this can penetrate the preservative applied to the timber and accelerate the rotting process - Monitor for any deterioration (rot) and replace as required

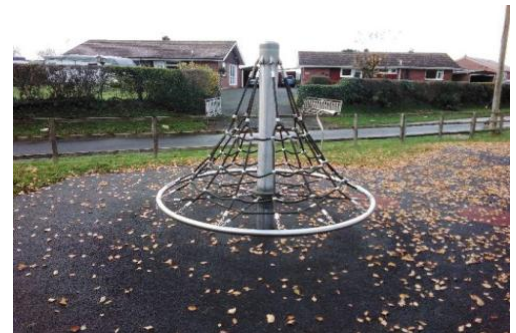
**Item:** Cone Climber  
**Manufacturer:** Tayplay Ltd  
**Surface Type:** Wet Pour  
**Item Quantity:** 1  
**Equipment Compliance:** Yes  
**Surface Area Compliance:** Yes

There are gaps opening between the surfacing and the edging surround or between the joints in the surfacing - Monitor for any further deterioration and repair as required

The bearing is showing signs of wear - Monitor for any further deterioration and replace as required

There appears to be components missing resulting in projecting brackets on the support - Refer to manufacturer as to the missing components

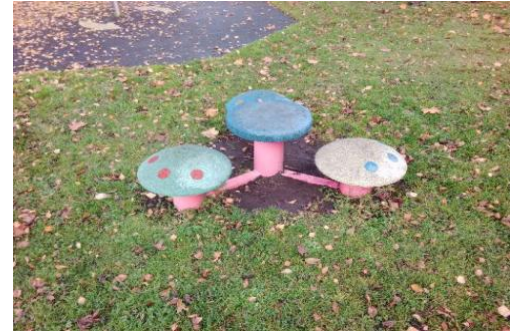
**Item:** Toadstools & Table  
**Manufacturer:** Unknown  
**Surface Type:** Grass  
**Item Quantity:** 1  
**Equipment Compliance:** N/A  
**Surface Area Compliance:** N/A

The area around the item has eroded and may become slippery - Reinststate eroded area

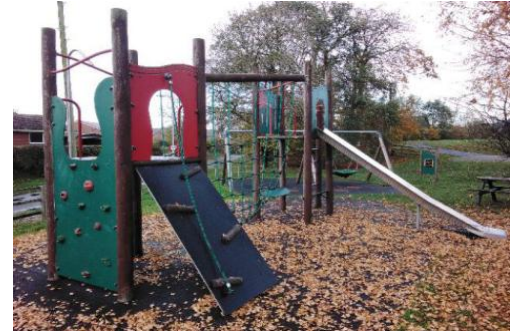
**Item:** Multi Play (Junior)  
**Manufacturer:** Playdale Playgrounds Ltd  
**Surface Type:** Wet Pour  
**Item Quantity:** 1  
**Equipment Compliance:** No  
**Surface Area Compliance:** No

There are gaps opening between the surfacing and the edging surround or between the joints in the surfacing - Monitor for any further deterioration and repair as required

The surface is lifting at the edges and creating trip points - Repair perimeter of surfacing to remove trip points

There are a number of dents in the slide surface - Monitor for any further deterioration and repair as required

Parts of the steel on this item have corroded excessively and the metal has perforated in places - Ensure all affected areas are treated and repaired

The timber has a number of splits/shakes or air cracks and this may affect the stability or allow water ingress which will accelerate the rotting process - Monitor to ensure the splits do not cross through fixing points of the structure and/or cause any instability

There is/are bolt cap covers missing or damaged on the item - Replace missing or damaged bolt cap covers

There are trip hazards at the edges of the surface - Reinstate surrounding surface levels to remove the trip points

The surfacing dimensions are short and do not meet with the requirements of the current applicable standard - Monitor - no remedial action recommended

The ropes/nets are worn/damaged in places - Monitor for any further deterioration and repair or replace as required

There is/are finger entrapment/s in the framework and the item fails to meet the requirements of BS EN 1176 Part 1 4.2.7.6 Entrapment of fingers - Monitor - No remedial work recommended

Rope ferrules are corroding on the scramble net - Monitor for any further deterioration and replace as required

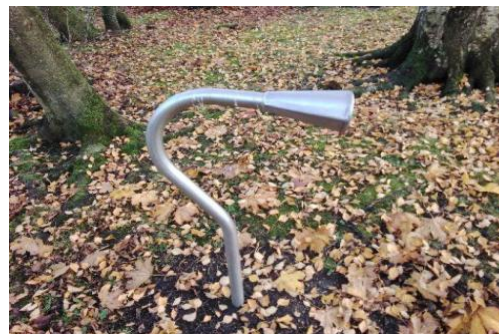
**Item:** Talk Tubes  
**Manufacturer:** Playdale Playgrounds Ltd  
**Surface Type:** Grass  
**Item Quantity:** 1  
**Equipment Compliance:** Yes  
**Surface Area Compliance:** N/A

The surface has eroded in some areas - Reinstate the surface

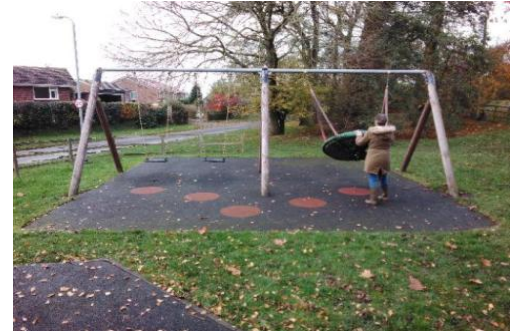
**Item:** 2 Bay 2 Flat 1 Basket Seat  
**Manufacturer:** Playdale Playgrounds Ltd  
**Surface Type:** Wet Pour  
**Item Quantity:** 1  
**Equipment Compliance:** No  
**Surface Area Compliance:** Yes

The safety surface under or around this unit has been damaged - Monitor for any further deterioration and repair as required

The timber edge has rotted - Replace timber edge

There are areas or parts of the timber on the structure that have rotted - Replace all affected timbers

The seat is severely damaged and requires replacing - Repair damaged seat

The bushes are worn or missing - Replace worn or missing bushes

The chain links are worn in excess of 40% and require renewing - Replace worn chains

The bushes are showing signs of wear - Monitor for any further deterioration and replace as required

There is some wear to the shackles. - Monitor for any further deterioration and replace when 40% worn

There are trip hazards at the edges of the surface - Reinstate surrounding surface levels to remove the trip points

The timber has a number of splits/shakes or air cracks and this may affect the stability or allow water ingress which will accelerate the rotting process - Monitor to ensure the splits do not cross through fixing points of the structure and/or cause any instability

Swings of this design should have a secondary safety device fitted to prevent collapse of the seat in the event of a joint failure to meet the requirements of BS EN 1176 Part 2 - Consider providing a secondary safety device where possible

The shackles are worn in excess of 40% and require renewing, raised risk as no safety chain - Replace worn shackles

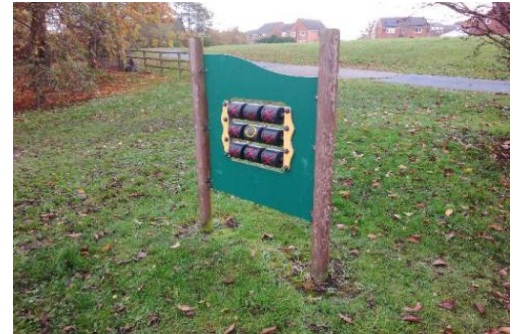
**Item:** Play Panel  
**Manufacturer:** Playdale Playgrounds Ltd  
**Surface Type:** Grass  
**Item Quantity:** 1  
**Equipment Compliance:** Yes  
**Surface Area Compliance:** N/A

There is some strimmer / machinery damage apparent on the posts, this can penetrate the preservative applied to the timber and accelerate the rotting process - Monitor for any deterioration (rot) and replace as required

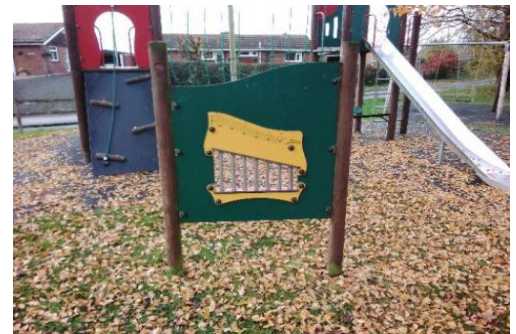
**Item:** Musical Instrument  
**Manufacturer:** Playdale Playgrounds Ltd  
**Surface Type:** Grass  
**Item Quantity:** 1  
**Equipment Compliance:** Yes  
**Surface Area Compliance:** N/A

There is some strimmer / machinery damage apparent on the posts, this can penetrate the preservative applied to the timber and accelerate the rotting process - Monitor for any deterioration (rot) and replace as required

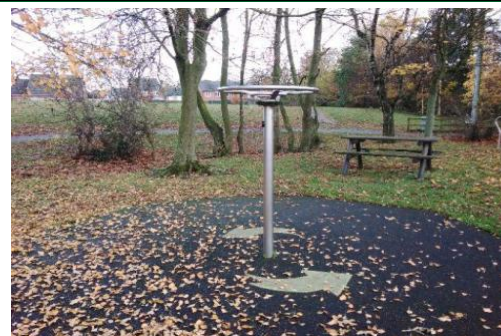
**Item:** Overhead Rotator  
**Manufacturer:** Playdale Playgrounds Ltd  
**Surface Type:** Wet Pour  
**Item Quantity:** 1  
**Equipment Compliance:** Yes  
**Surface Area Compliance:** Yes

The tree canopy overhangs the equipment and is less than 2.0m away - Lift tree canopy to ensure a minimum clearance of 2.0m from the equipment

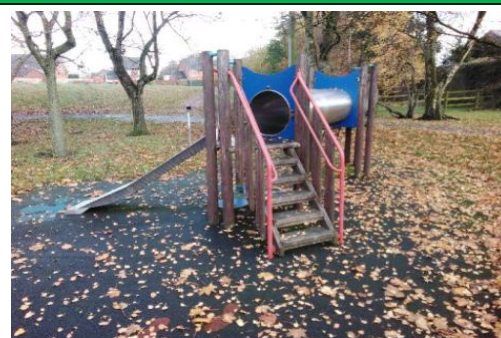
**Item:** Multi Play (Toddler)  
**Manufacturer:** Playdale Playgrounds Ltd  
**Surface Type:** Wet Pour  
**Item Quantity:** 1  
**Equipment Compliance:** Yes  
**Surface Area Compliance:** Yes

There are gaps opening between the surfacing and the edging surround or between the joints in the surfacing - Monitor for any further deterioration and repair as required

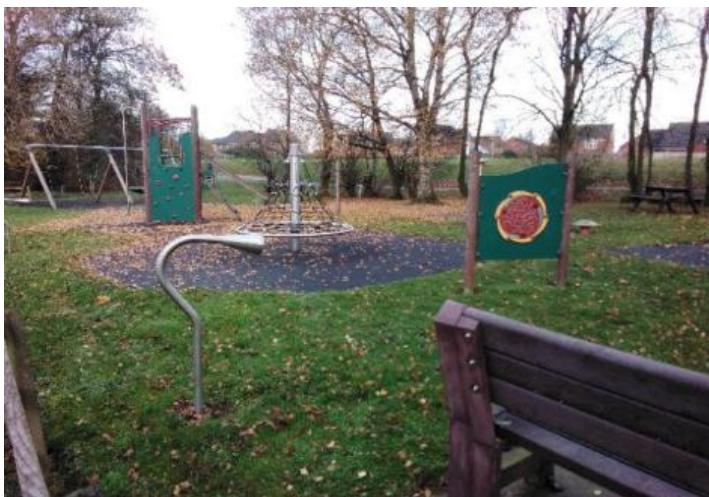
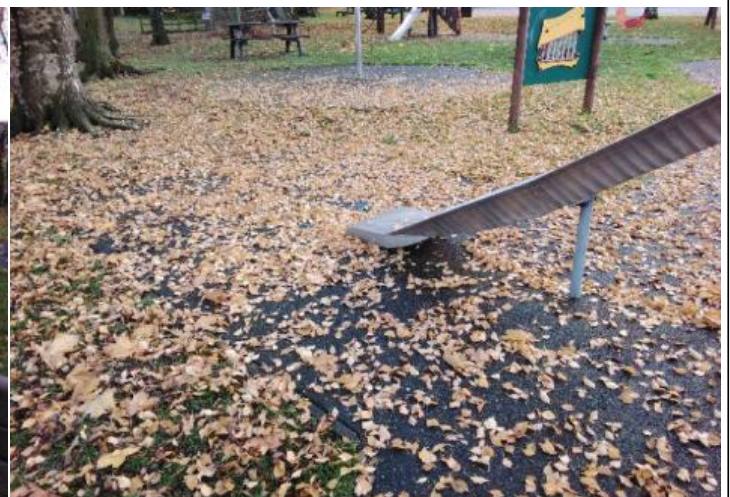
**Item:** Ancillary Items - Site General  
**Manufacturer:** Owner/Operator

**Finding:** There is some tree debris on the surfacing

**Action:** Remove and maintain

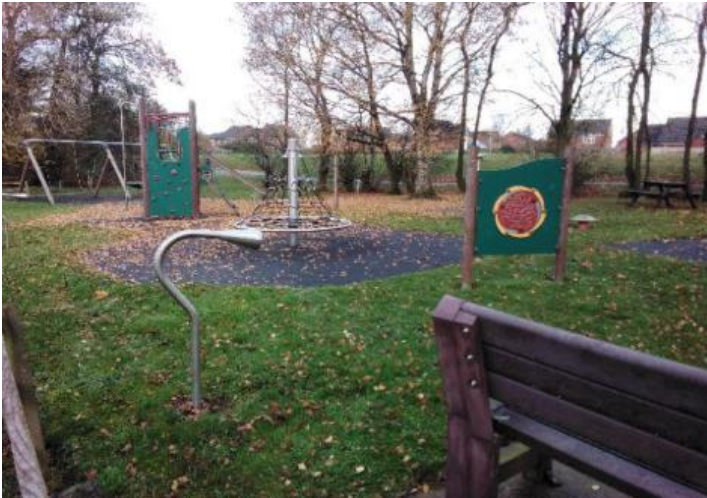
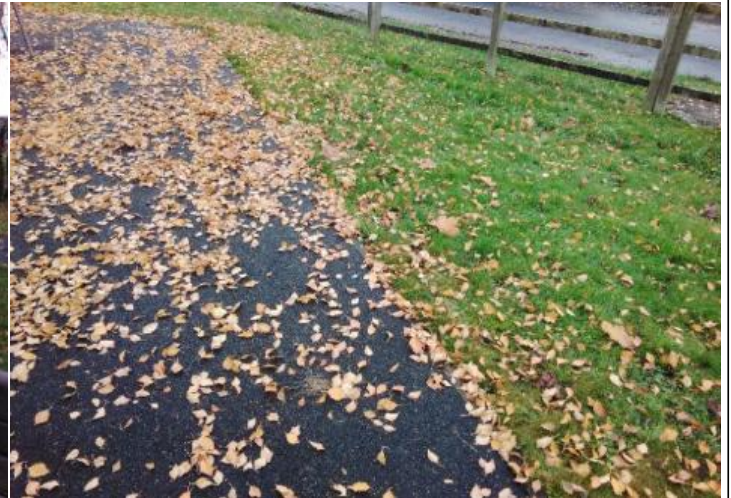
**Item:** Ancillary Items - Site General  
**Manufacturer:** Owner/Operator

**Finding:** There are weeds/vegetation growth between or around the edges of the surfacing

**Action:** Remove weeds/vegetation growth

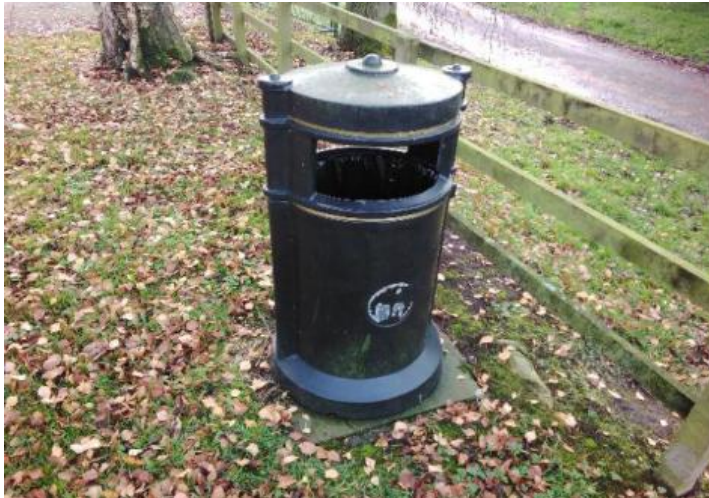
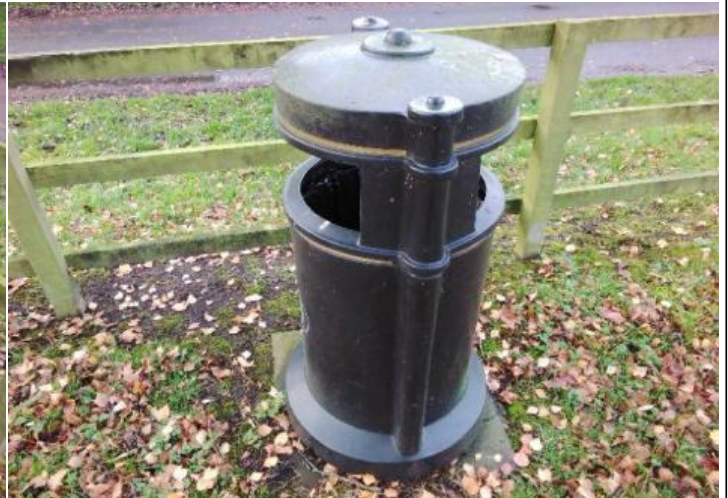
**Item:** Ancillary Items - Litter Bin  
**Manufacturer:** Owner/Operator

**Finding:** The lid or door of the litter bin is not secured

**Action:** Ensure the lid or door is kept locked

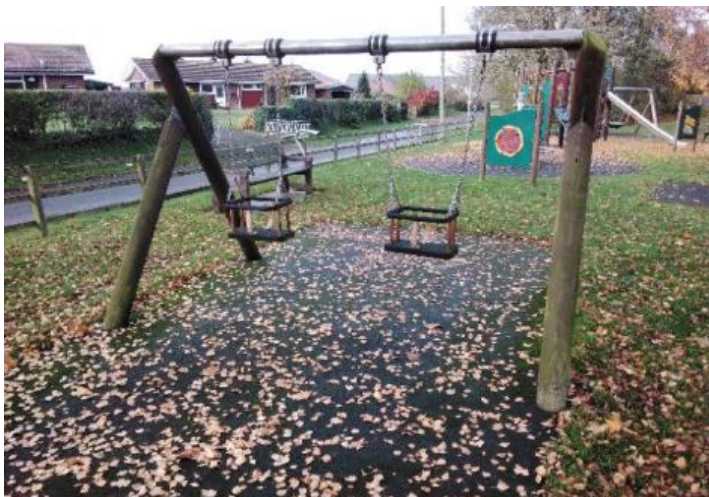
**Finding:** The seat is severely damaged and requires replacing

**Action:** Replace damaged seat

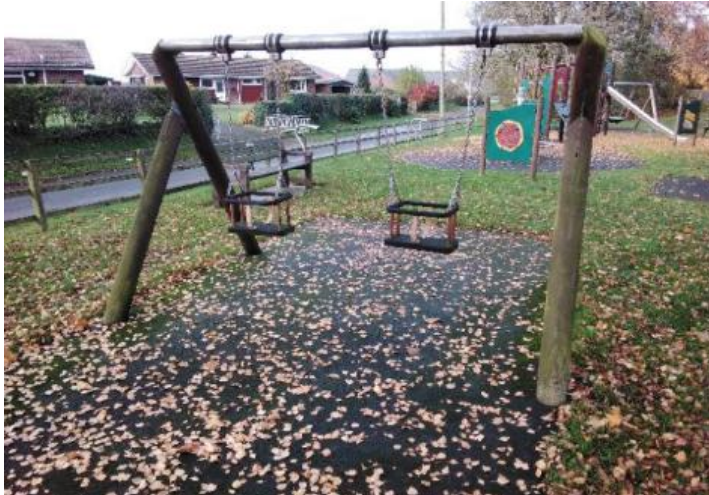
**Finding:** There are areas or parts of the timber on the structure that have rotted

**Action:** Replace all affected timbers

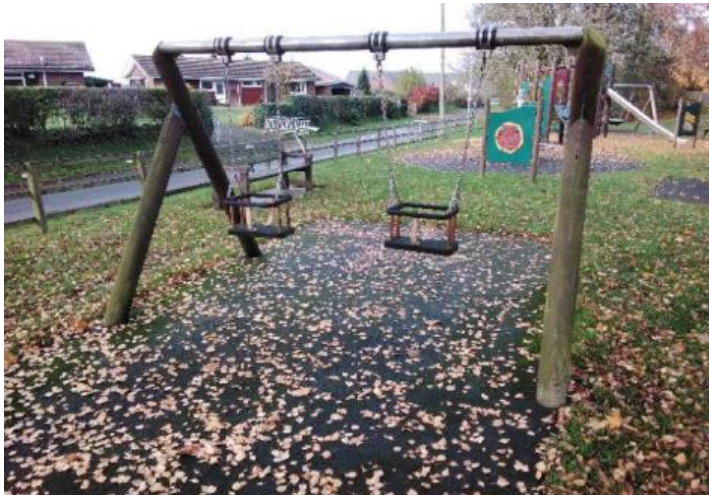
**Finding:** There are areas or parts of the timber on the structure that have rotted

**Action:** Replace all affected timbers

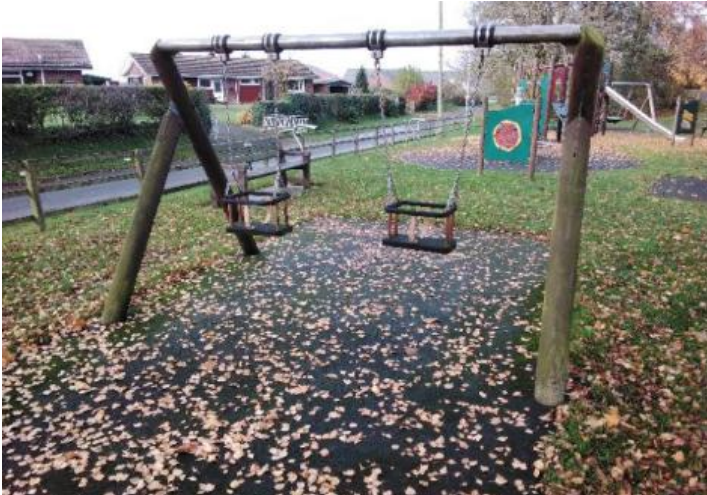
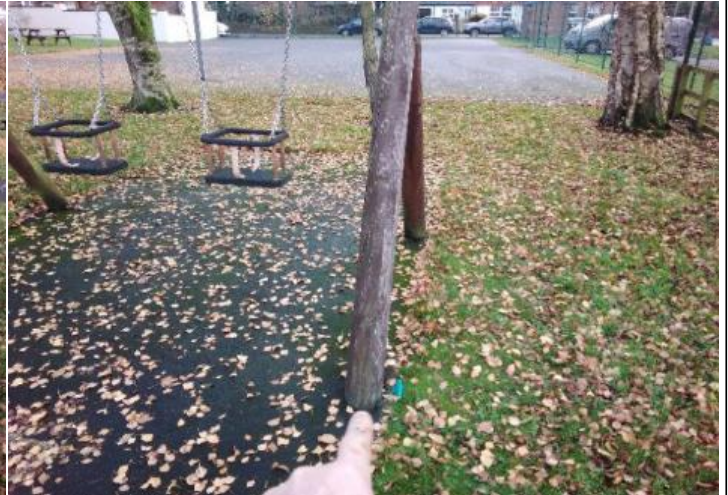
**Finding:** There are areas or parts of the timber on the structure that have rotted

**Action:** Replace all affected timbers

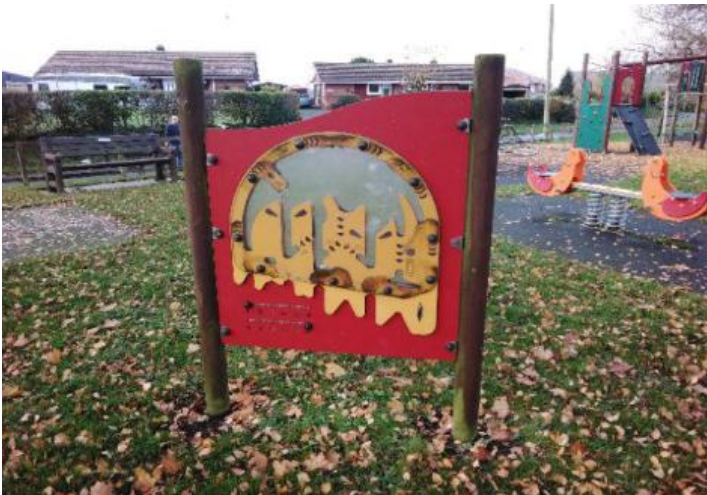
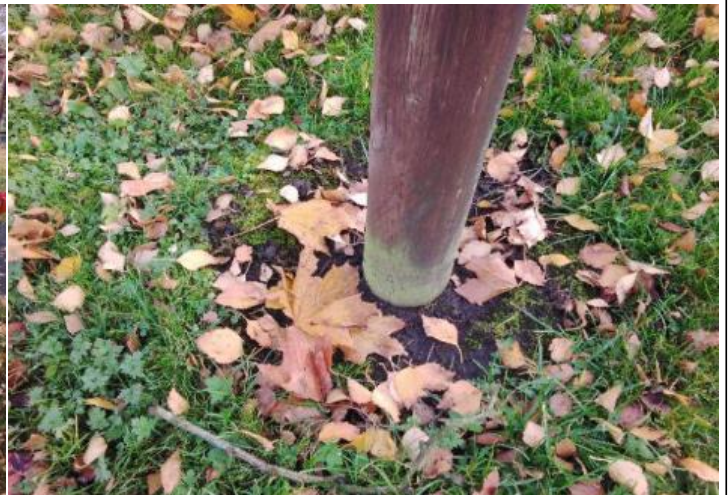
**Finding:** There is some strimmer / machinery damage apparent on the posts, this can penetrate the preservative applied to the timber and accelerate the rotting process

**Action:** Monitor for any deterioration (rot) and replace as required

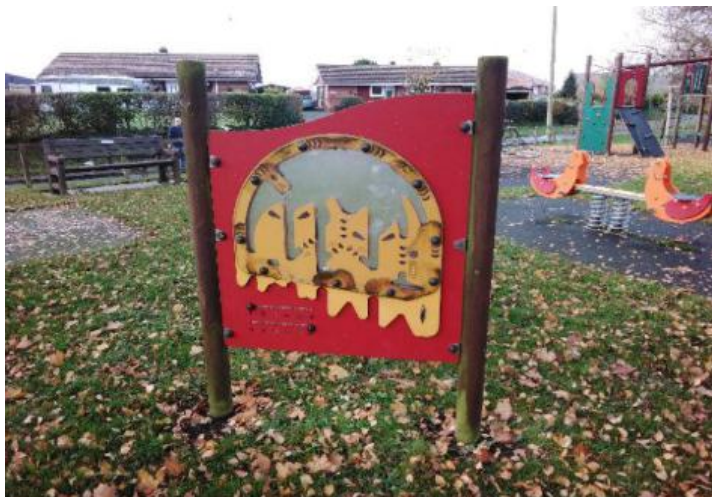
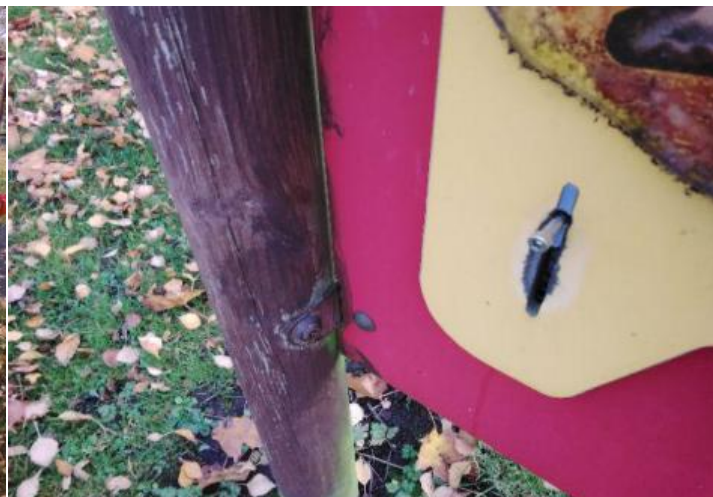
**Finding:** The lever cap is missing

**Action:** Replace lever cap

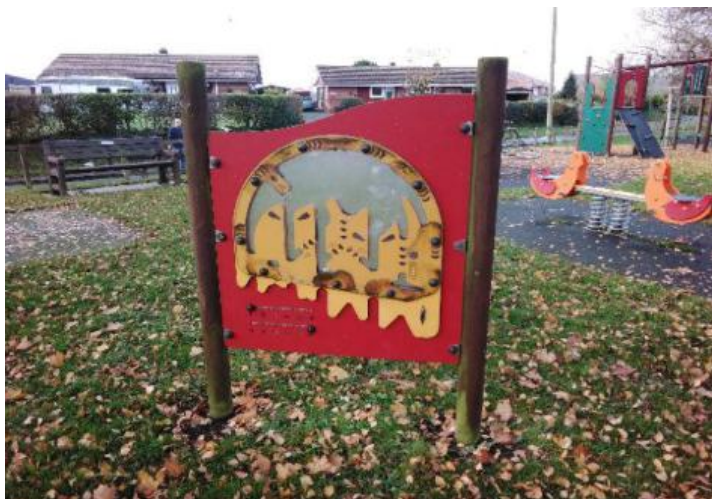
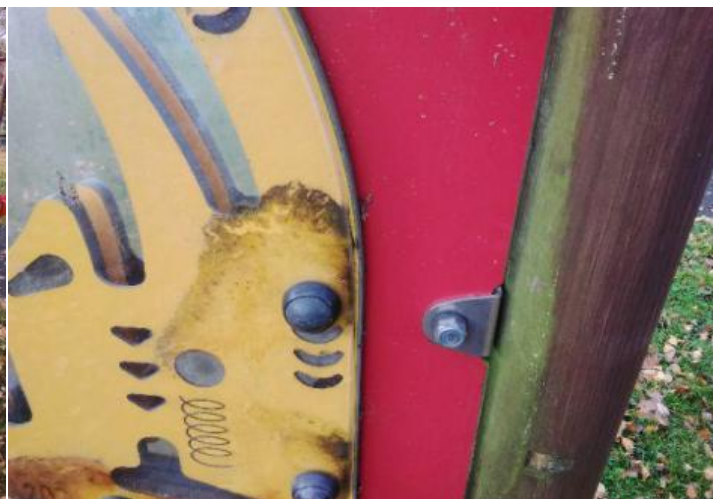
**Finding:** There is/are bolt cap covers missing or damaged on the item

**Action:** Replace missing or damaged bolt cap covers

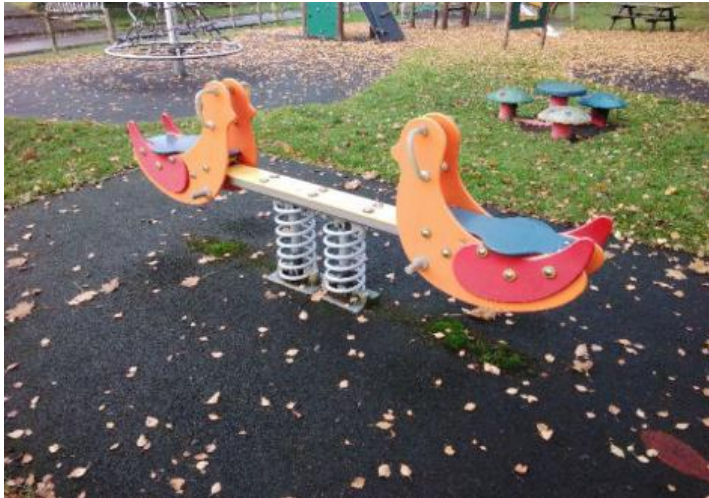
**Finding:** The end of handgrips and/or footrests have a cross section of less than 15cm<sup>2</sup> and fail to meet the requirements of BS EN 1176 Part 6  
**Action:** Monitor - No remedial work recommended

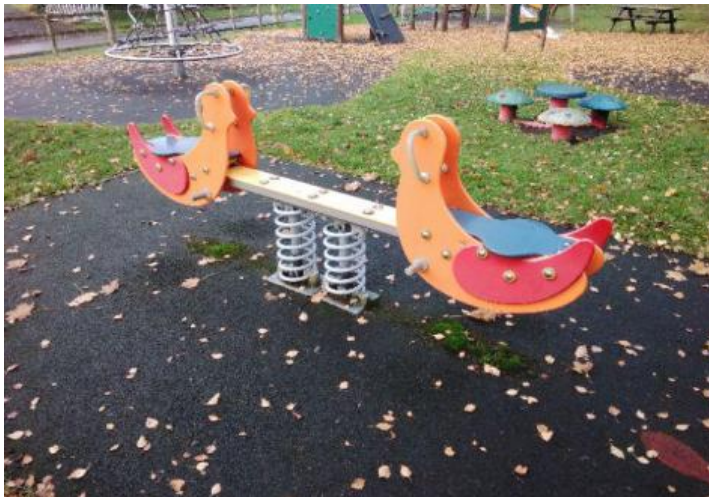
**Finding:** There are gaps opening between the surfacing and the edging surround or between the joints in the surfacing  
**Action:** Monitor for any further deterioration and repair as required

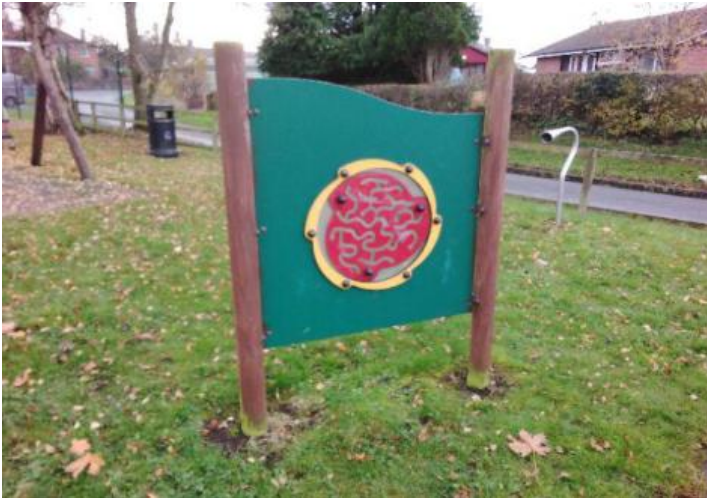
**Finding:** There is some strimmer / machinery damage apparent on the posts, this can penetrate the preservative applied to the timber and accelerate the rotting process

**Action:** Monitor for any deterioration (rot) and replace as required

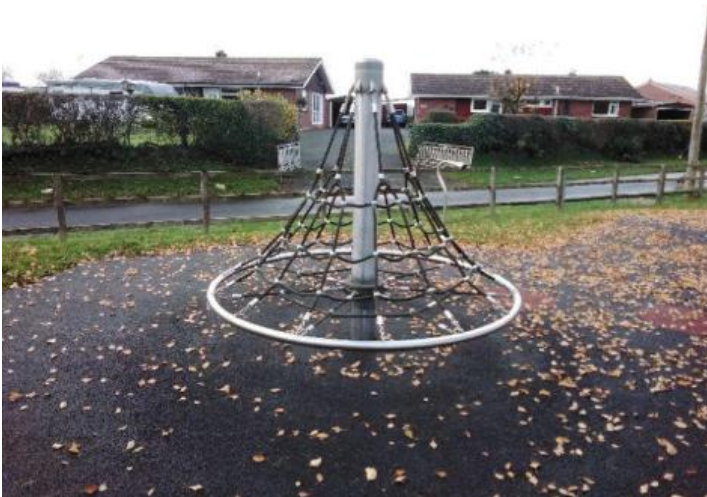
**Finding:** There are gaps opening between the surfacing and the edging surround or between the joints in the surfacing

**Action:** Monitor for any further deterioration and repair as required

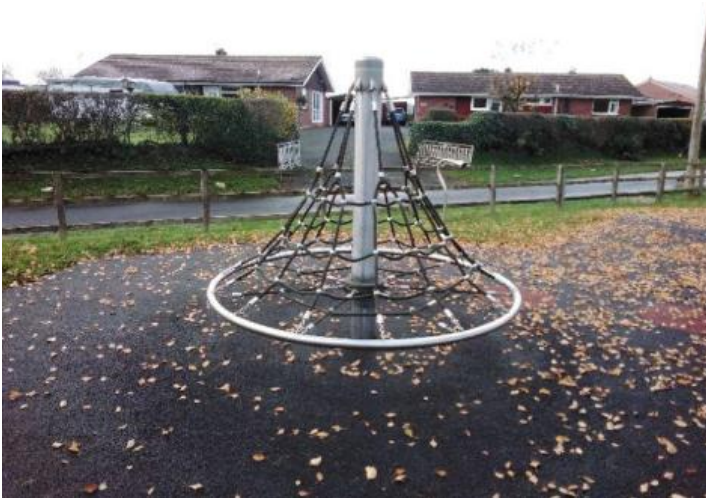
**Finding:** The bearing is showing signs of wear

**Action:** Monitor for any further deterioration and replace as required

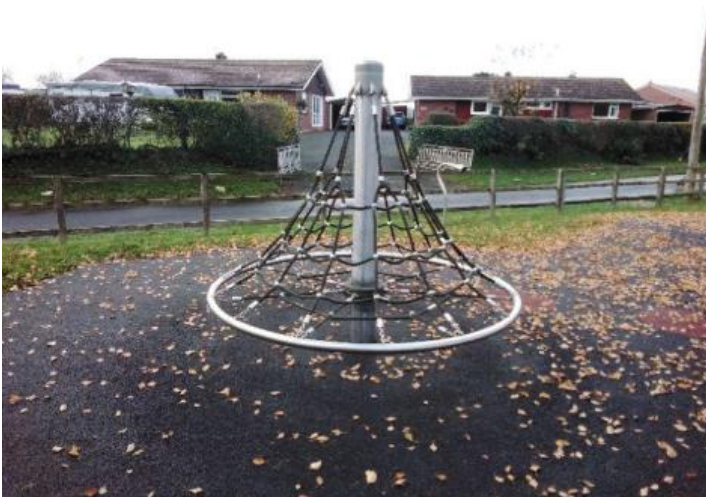
**Finding:** There appears to be components missing resulting in projecting brackets on the support

**Action:** Refer to manufacturer as to the missing components

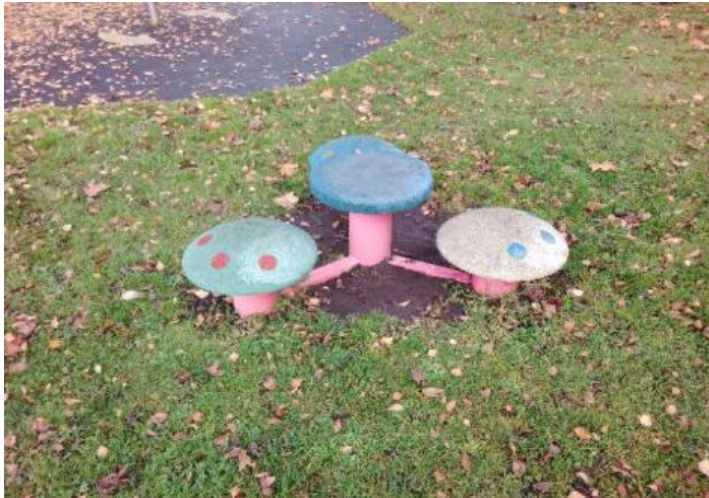
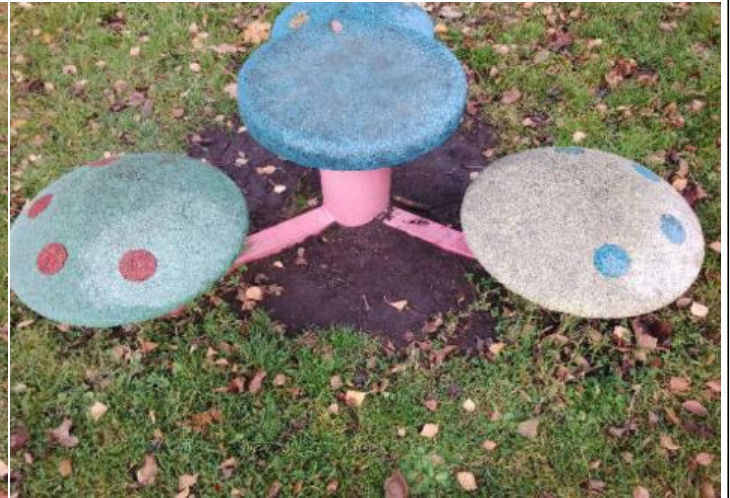
**Finding:** The area around the item has eroded and may become slippery

**Action:** Reinstatate eroded area

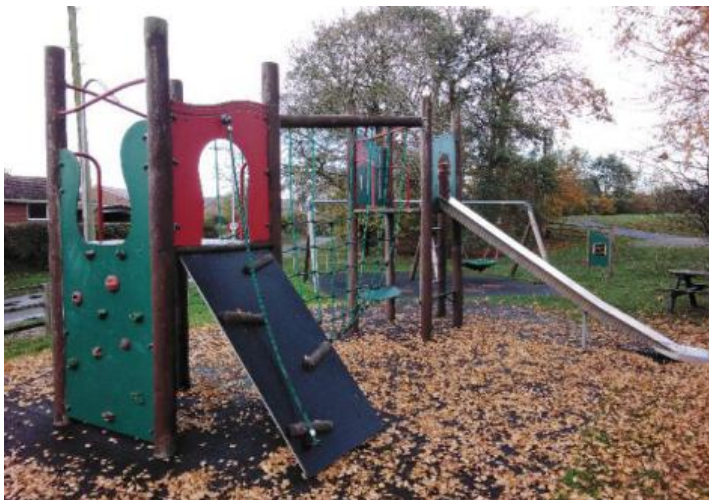
**Finding:** There are gaps opening between the surfacing and the edging surround or between the joints in the surfacing

**Action:** Monitor for any further deterioration and repair as required

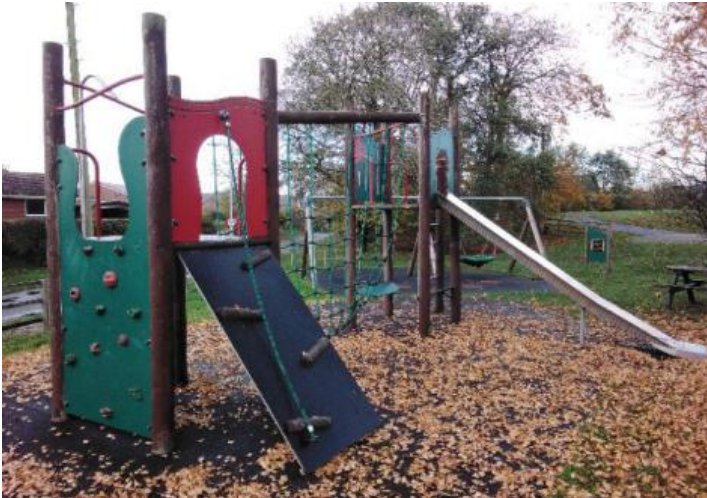
**Finding:** There are trip hazards at the edges of the surface

**Action:** Reinstate surrounding surface levels to remove the trip points

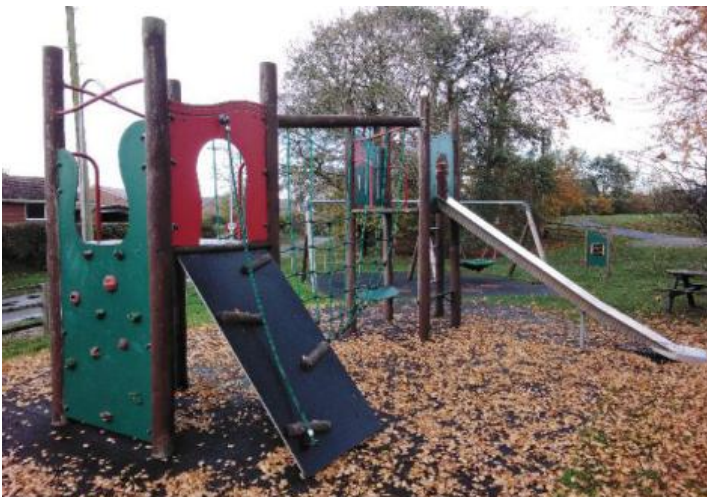
**Finding:** The surface is lifting at the edges and creating trip points

**Action:** Repair perimeter of surfacing to remove trip points

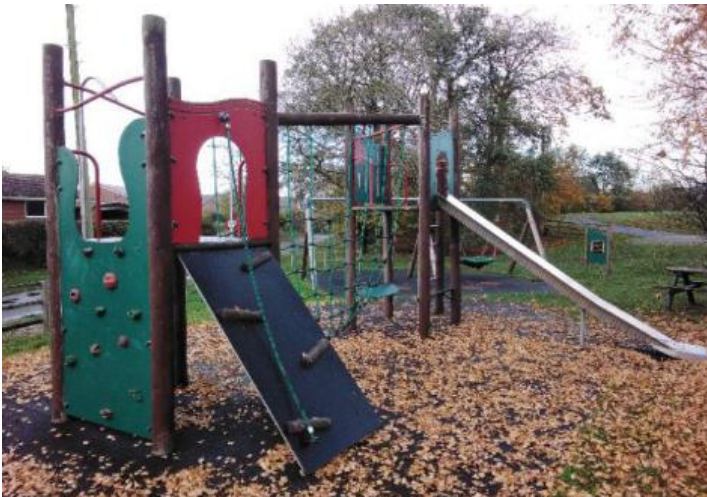
**Finding:** There are a number of dents in the slide surface

**Action:** Monitor for any further deterioration and repair as required

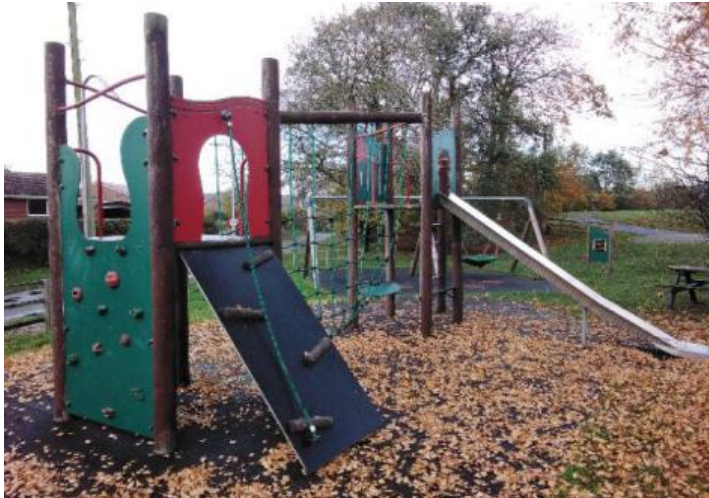
**Finding:** The ropes/nets are worn/damaged in places

**Action:** Monitor for any further deterioration and repair or replace as required

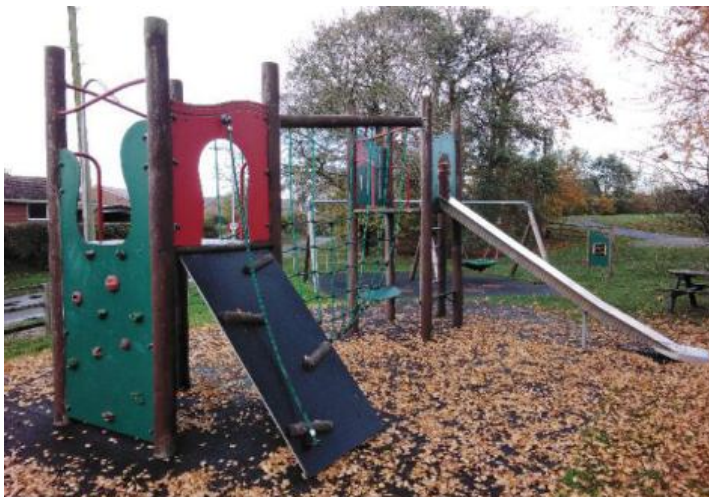
**Finding:** There is/are finger entrapment/s in the framework and the item fails to meet the requirements of BS EN 1176 Part 1 4.2.7.6 Entrapment of fingers

**Action:** Monitor - No remedial work recommended

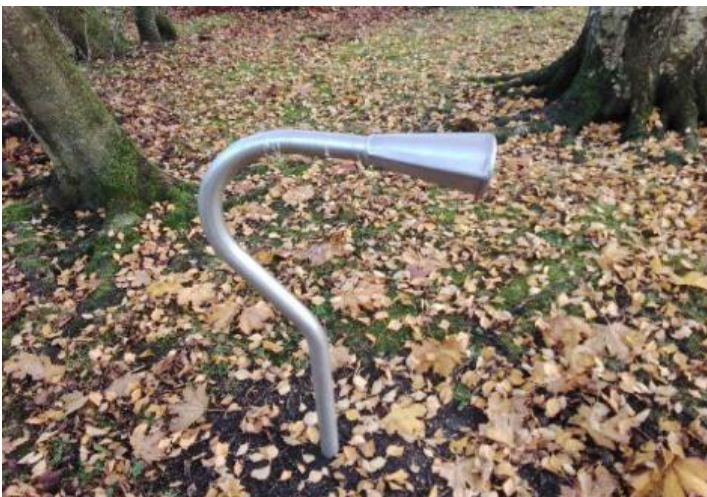
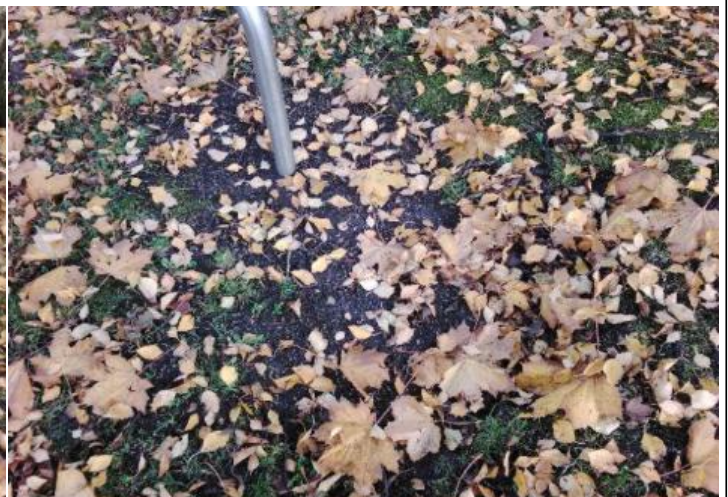
**Finding:** The surface has eroded in some areas

**Action:** Reinstate the surface

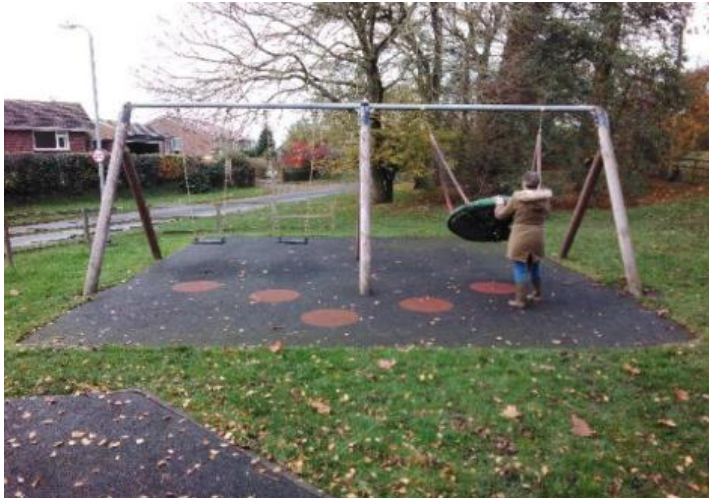
**Finding:** The safety surface under or around this unit has been damaged

**Action:** Monitor for any further deterioration and repair as required

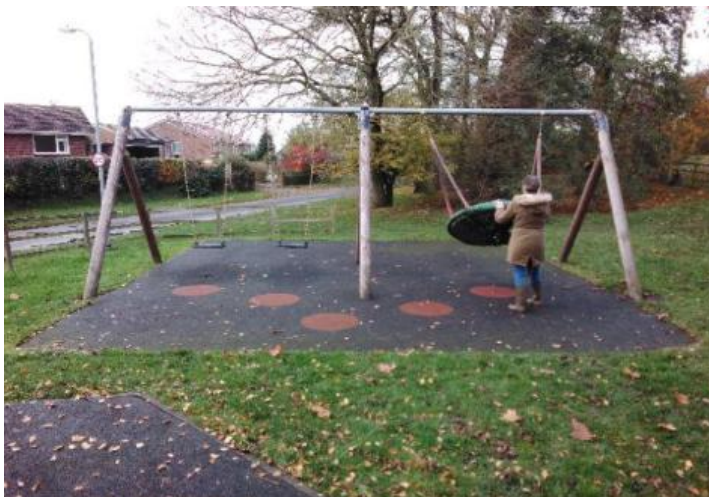
**Finding:** There are trip hazards at the edges of the surface

**Action:** Reinstate surrounding surface levels to remove the trip points

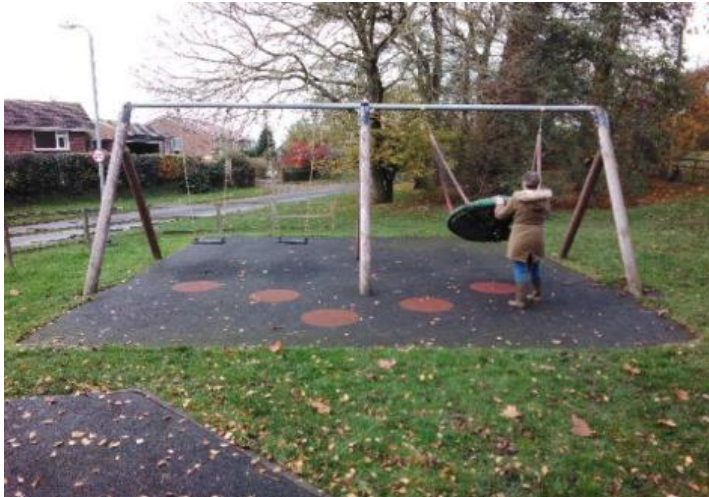
**Finding:** The timber has a number of splits/shakes or air cracks and this may affect the stability or allow water ingress which will accelerate the rotting process

**Action:** Monitor to ensure the splits do not cross through fixing points of the structure and/or cause any instability

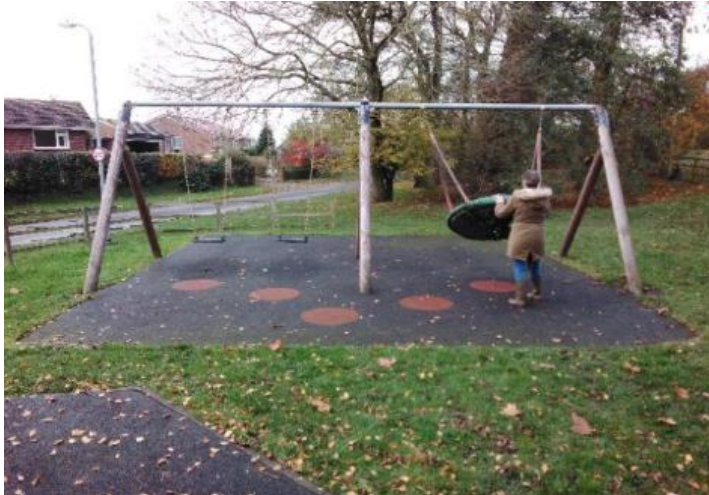
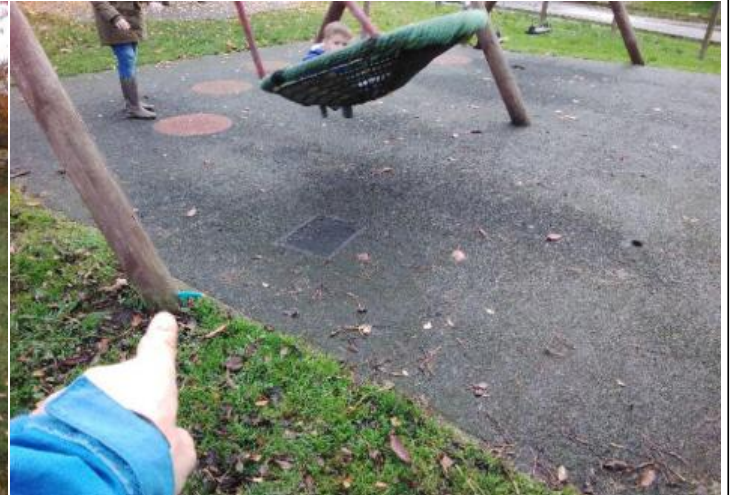
**Finding:** There are areas or parts of the timber on the structure that have rotted

**Action:** Replace all affected timbers

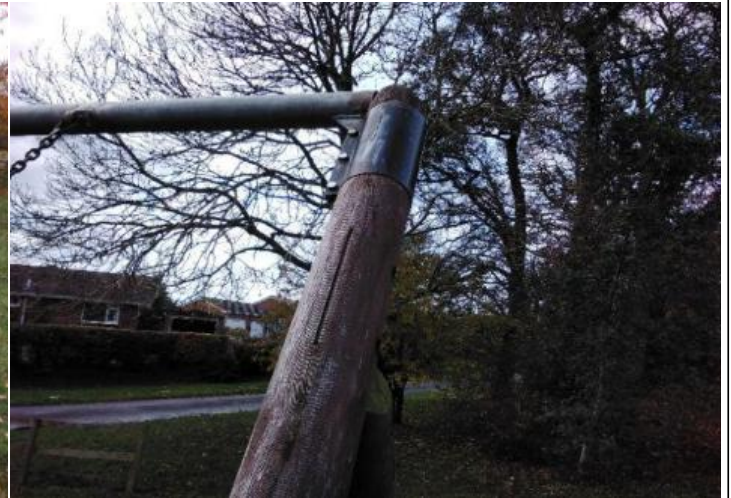
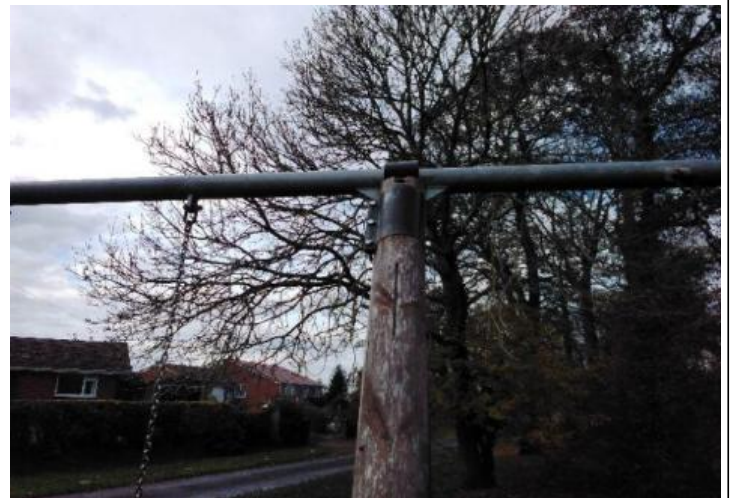
**Finding:** Additional brackets have been added to the frame for an unknown reason

**Action:** Remove brackets if not required

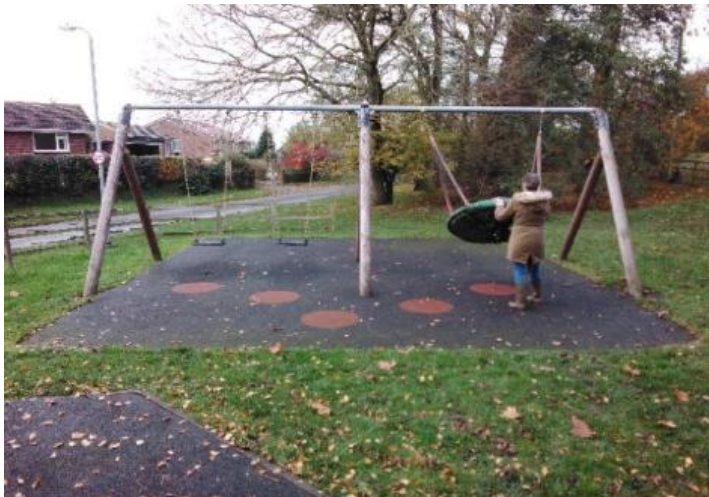
**Finding:** The shackles are worn in excess of 40% and require renewing, raised risk as no safety chain

**Action:** Replace worn shackles

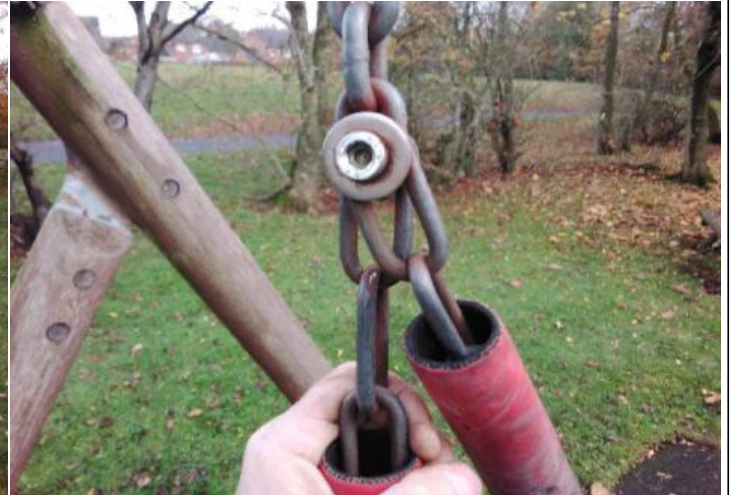
**Finding:** The chain links are worn in excess of 40% and require renewing

**Action:** Replace worn chains

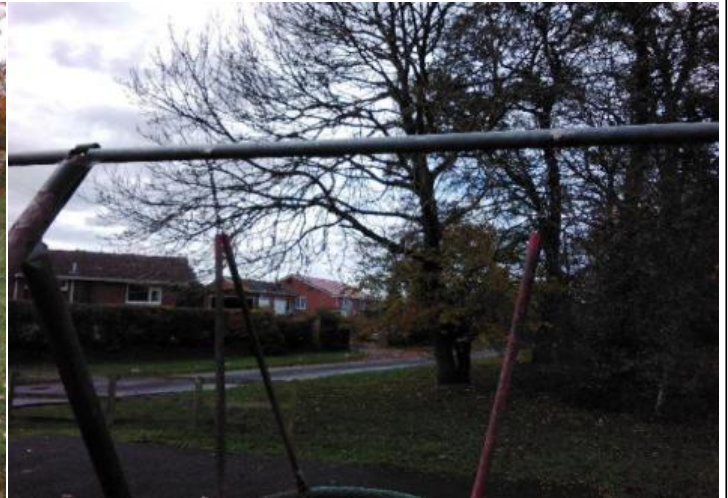
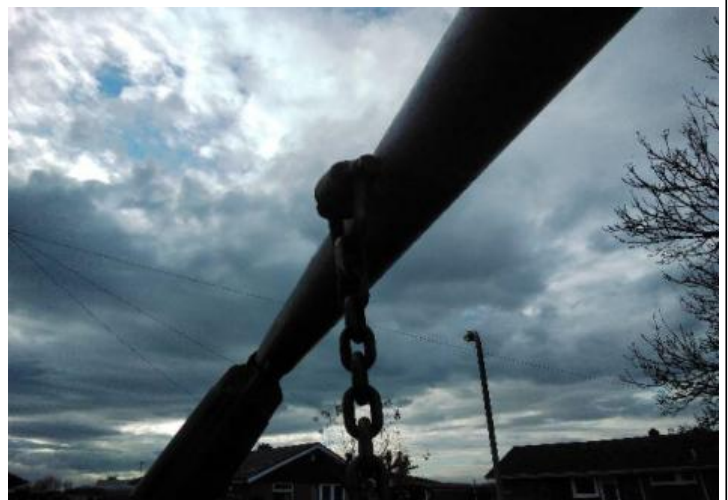
**Finding:** The basket swing lugs are set on an angle

**Action:** Refer to manufacturers as to correct fitment

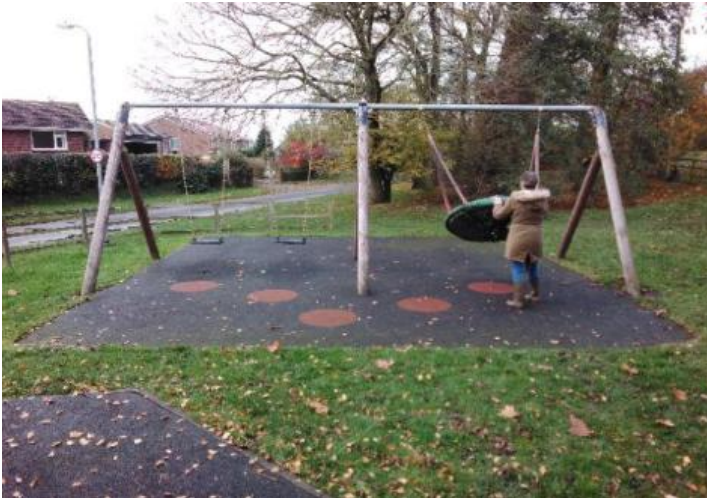
**Finding:** There is some wear to the shackles.

**Action:** Monitor for any further deterioration and replace when 40% worn
