## Annual Inspection

King Moor Parish Council

Cargo Village, Carlisle, Cumbria, CA6 4AR

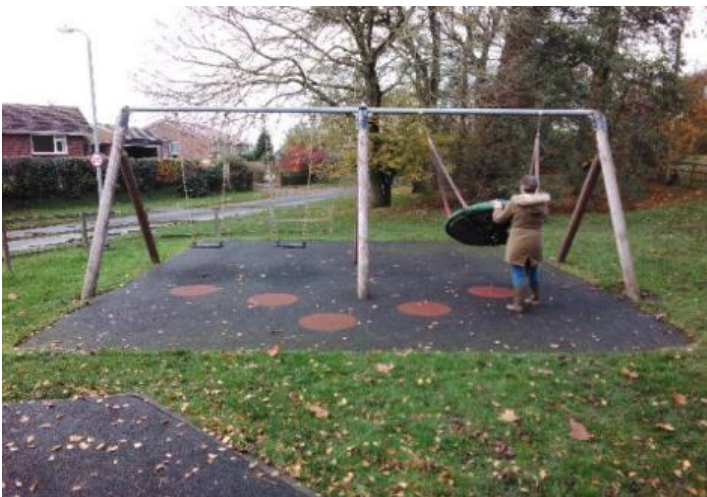
**Finding:** The chain openings are in excess of the 8.6mm as recommended by BS EN 1176

**Action:** Monitor - No remedial work recommended

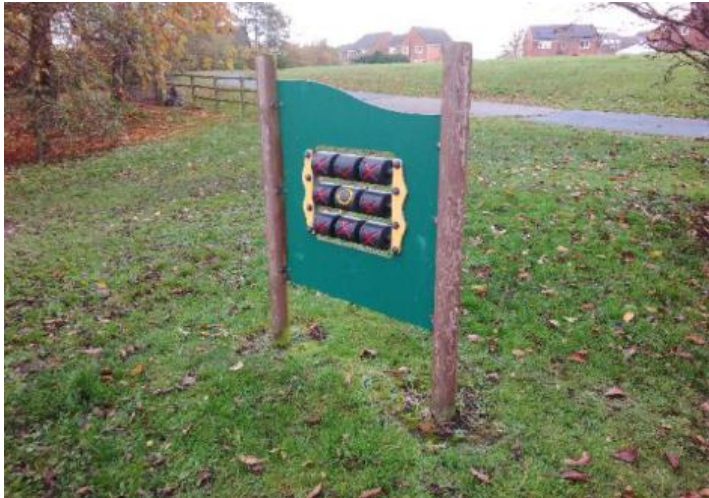
**Item:** Activity Equipment - Play Panel  
**Manufacturer:** Playdale Playgrounds Ltd

**Finding:** There is some strimmer / machinery damage apparent on the posts, this can penetrate the preservative applied to the timber and accelerate the rotting process

**Action:** Monitor for any deterioration (rot) and replace as required

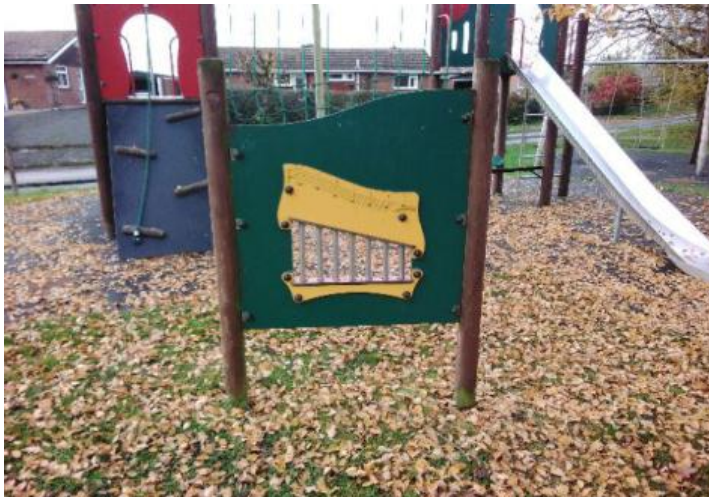
**Item:** Other - Musical Instrument  
**Manufacturer:** Playdale Playgrounds Ltd

**Finding:** There is some strimmer / machinery damage apparent on the posts, this can penetrate the preservative applied to the timber and accelerate the rotting process

**Action:** Monitor for any deterioration (rot) and replace as required

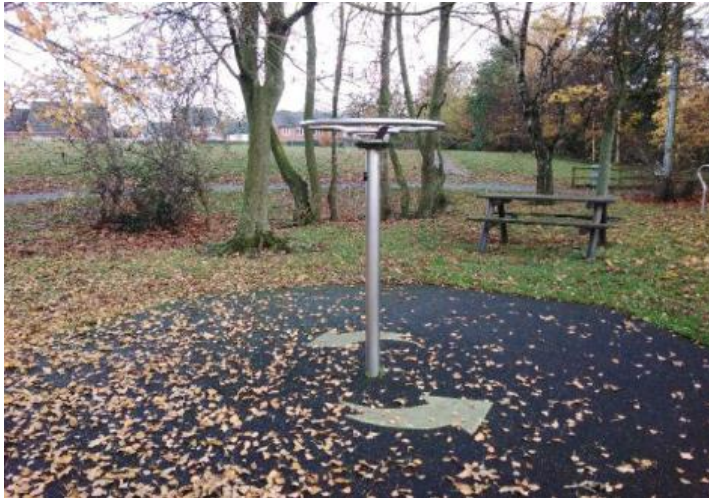
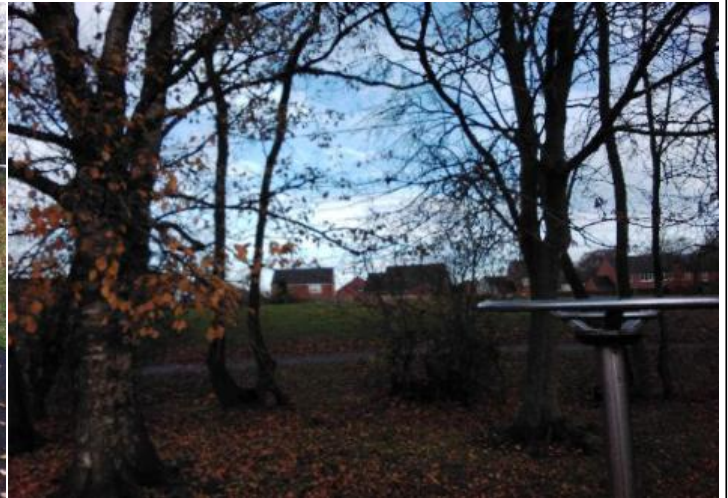
**Item:** Rotor Play - Overhead Rotator  
**Manufacturer:** Playdale Playgrounds Ltd

**Finding:** The tree canopy overhangs the equipment and is less than 2.0m away

**Action:** Lift tree canopy to ensure a minimum clearance of 2.0m from the equipment

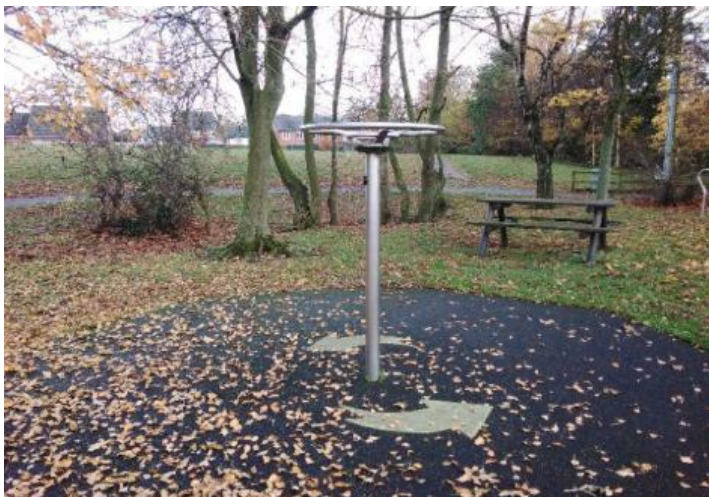
**Item:** Rotor Play - Overhead Rotator  
**Manufacturer:** Playdale Playgrounds Ltd

**Finding:** There are trip hazards at the edges of the surface

**Action:** Reinstate surrounding surface levels to remove the trip points

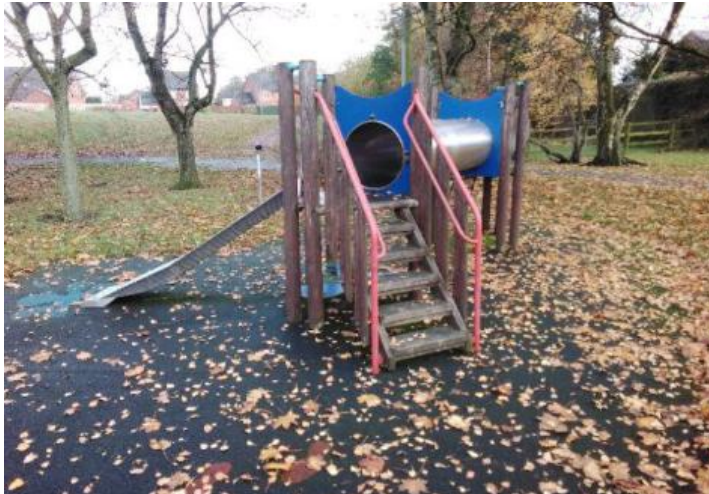
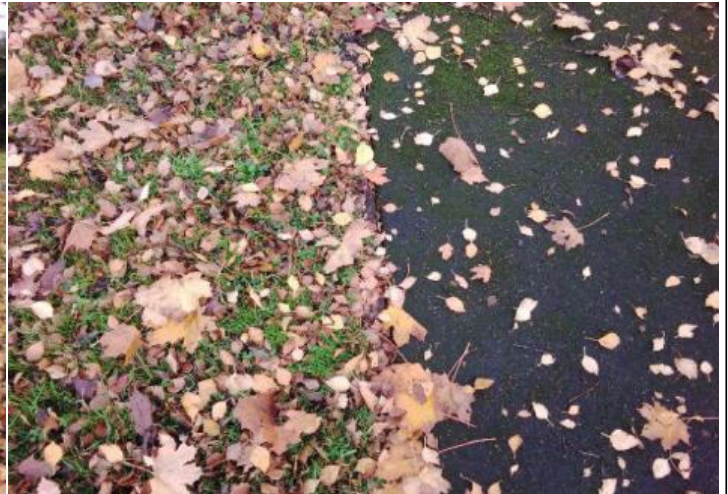
**Item:** Activity Equipment - Multi Play (Toddler)  
**Manufacturer:** Playdale Playgrounds Ltd

**Finding:** There are gaps opening between the surfacing and the edging surround or between the joints in the surfacing

**Action:** Monitor for any further deterioration and repair as required

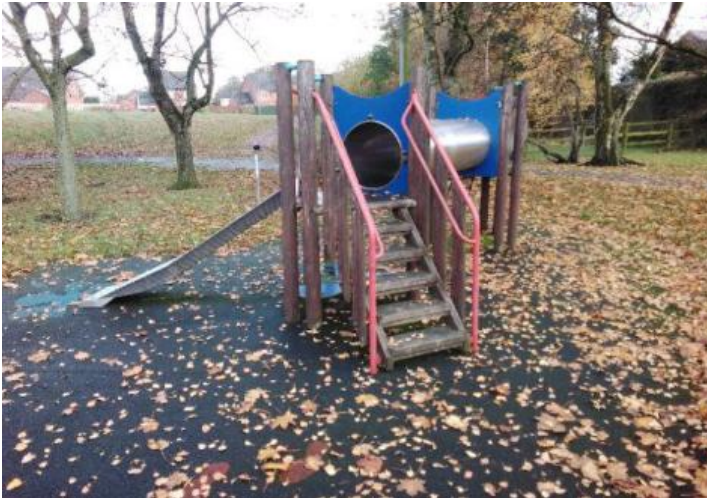
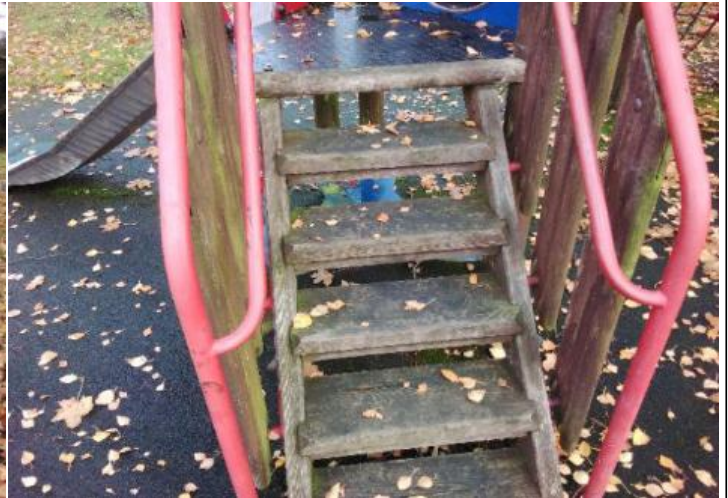
**Item:** Activity Equipment - Multi Play (Toddler)  
**Manufacturer:** Playdale Playgrounds Ltd

**Finding:** There is algae or moss on the surface of the equipment

**Action:** Clean and treat appropriately

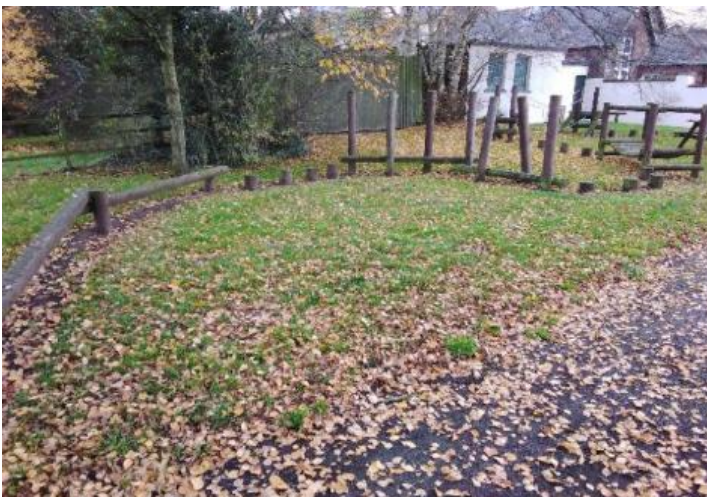
**Item:** Activity Equipment - Adventure Trail  
**Manufacturer:** Playdale Playgrounds Ltd

**Finding:** A damaged branch is hanging in in the fall space

**Action:** Remove damaged branch

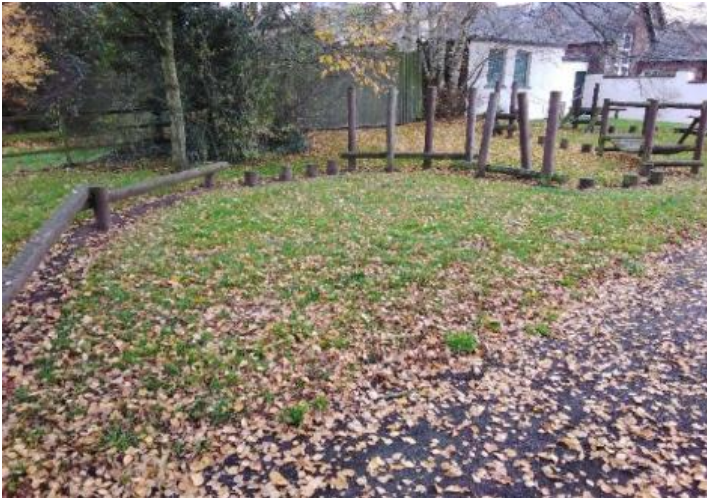
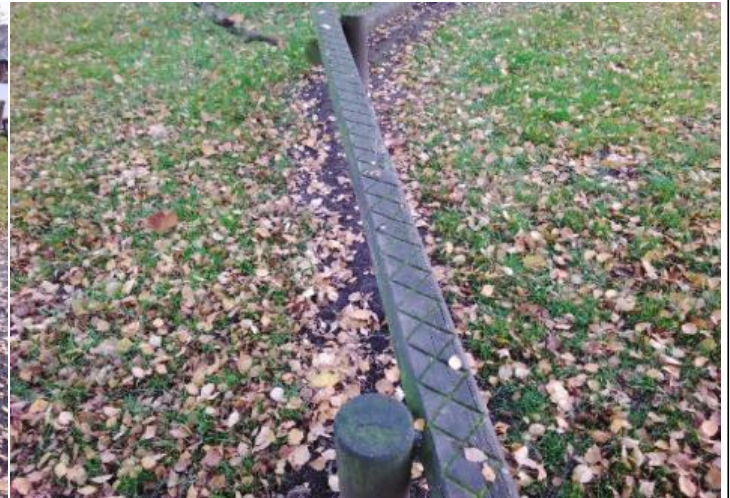
**Item:** Activity Equipment - Adventure Trail  
**Manufacturer:** Playdale Playgrounds Ltd

**Finding:** There is algae or moss on the surface of the equipment

**Action:** Clean and treat appropriately

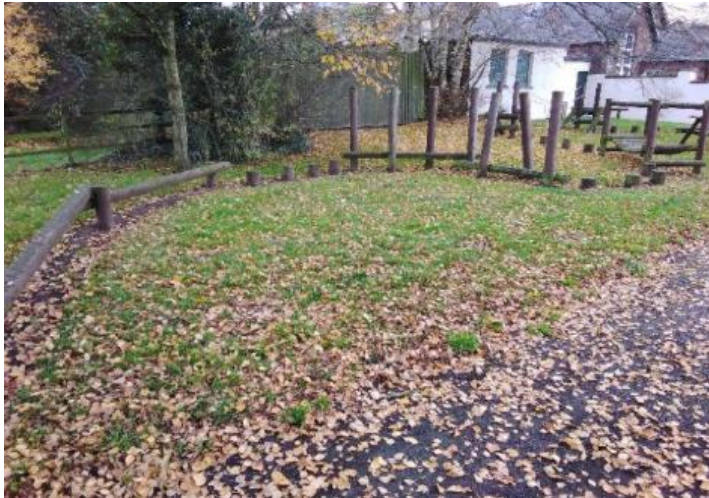
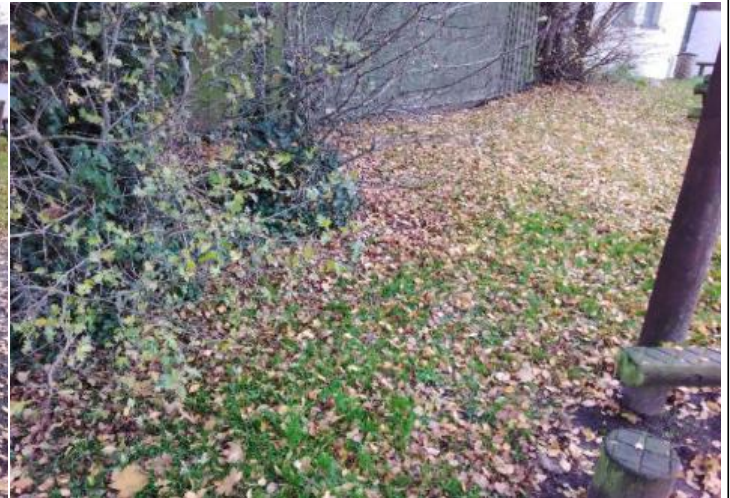
**Item:** Activity Equipment - Adventure Trail  
**Manufacturer:** Playdale Playgrounds Ltd

**Finding:** Foliage has encroached on the fall space of the equipment

**Action:** Cut back foliage

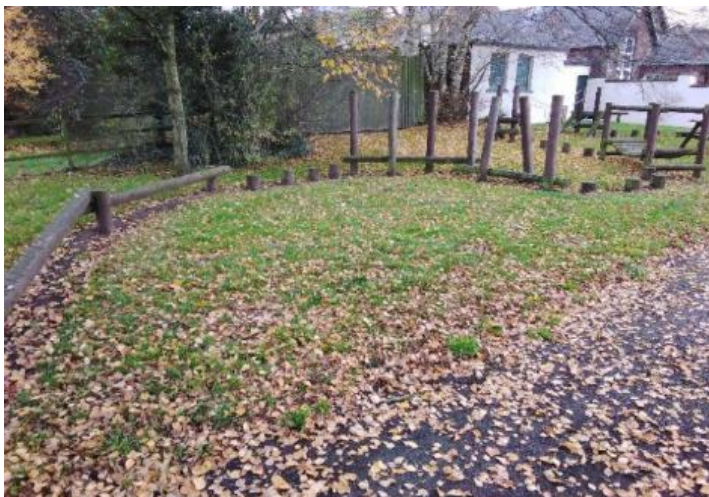
**Item:** Activity Equipment - Adventure Trail  
**Manufacturer:** Playdale Playgrounds Ltd

**Finding:** There are areas or parts of the timber on the structure that have rotted

**Action:** Replace all affected timbers

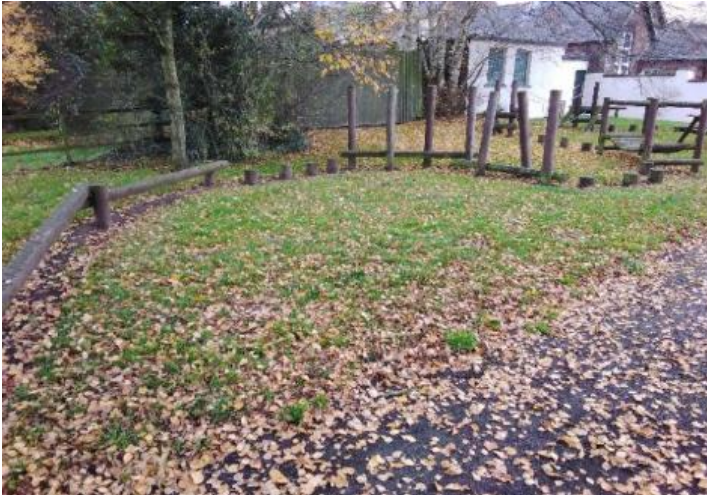
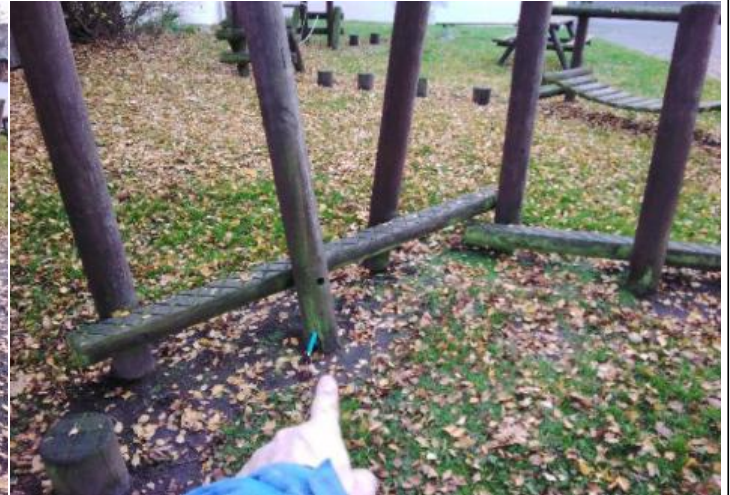
**Item:** Activity Equipment - Adventure Trail  
**Manufacturer:** Playdale Playgrounds Ltd

**Finding:** The timber on this item has severe rot

**Action:** Remove and replace all affected timber sections

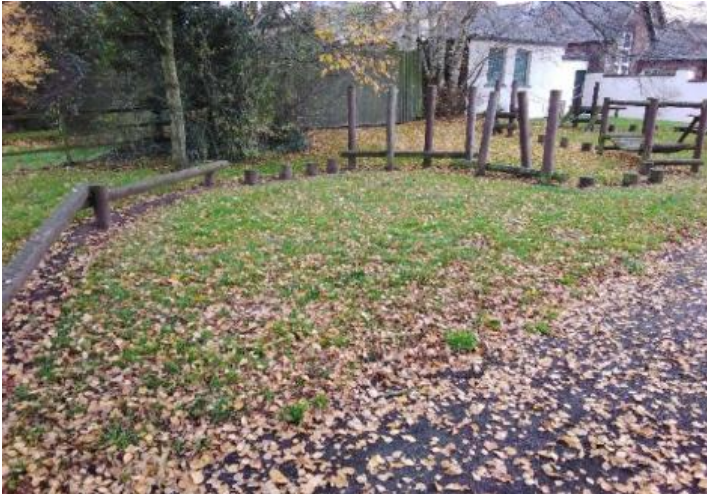
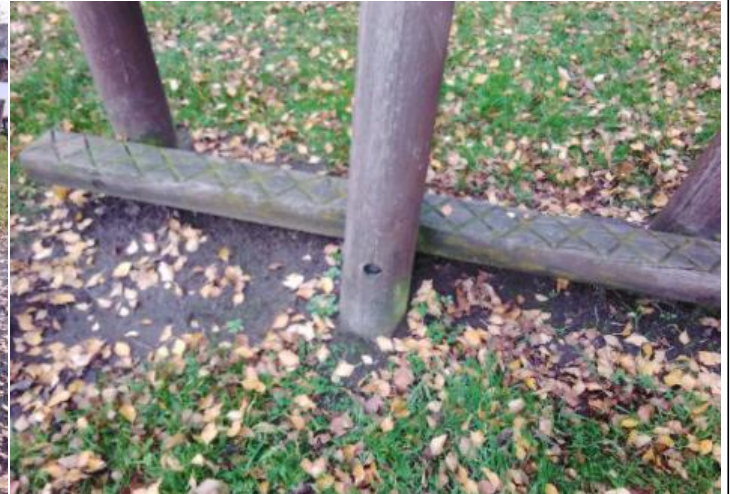
**Item:** Activity Equipment - Adventure Trail  
**Manufacturer:** Playdale Playgrounds Ltd

**Finding:** There is/are bolt cap covers missing or damaged on the item

**Action:** Replace missing or damaged bolt cap covers

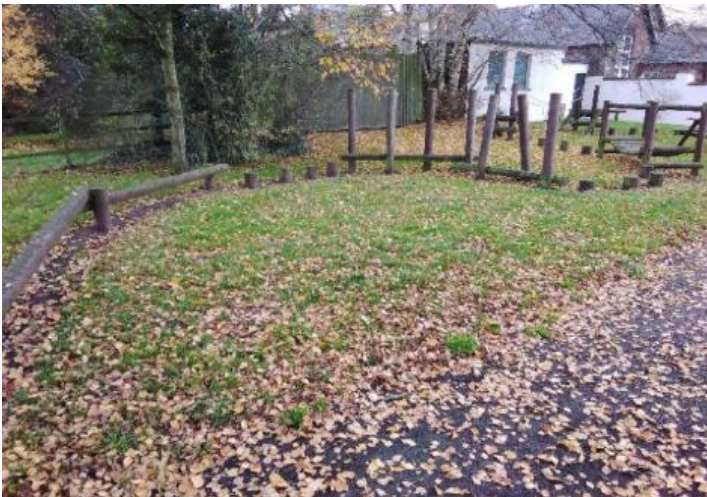
**Item:** Activity Equipment - Adventure Trail  
**Manufacturer:** Playdale Playgrounds Ltd

**Finding:** The timber on this item has severe rot

**Action:** Remove and replace all affected timber sections

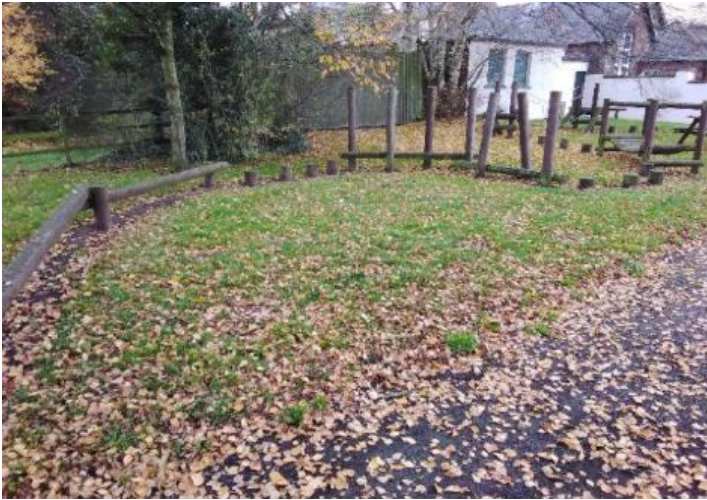
**Item:** Activity Equipment - Adventure Trail  
**Manufacturer:** Playdale Playgrounds Ltd

**Finding:** The surface has eroded and the foundations are exposed

**Action:** Reinstall surrounding surfaces to cover the foundations

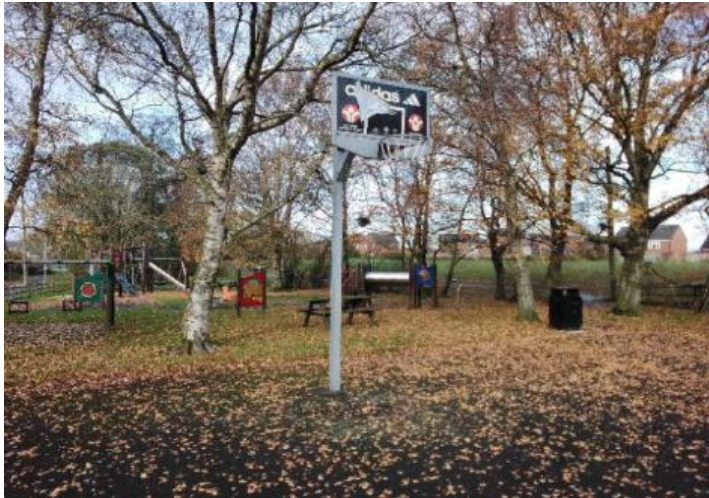
**Item:** Multi Use Games Area - Basketball Post  
**Manufacturer:** Unknown

**Finding:** The backboard is damaged

**Action:** Monitor for any further deterioration and repair as required

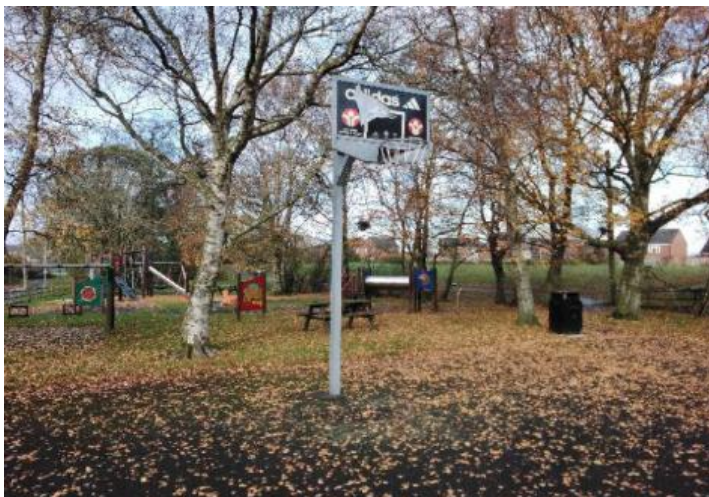
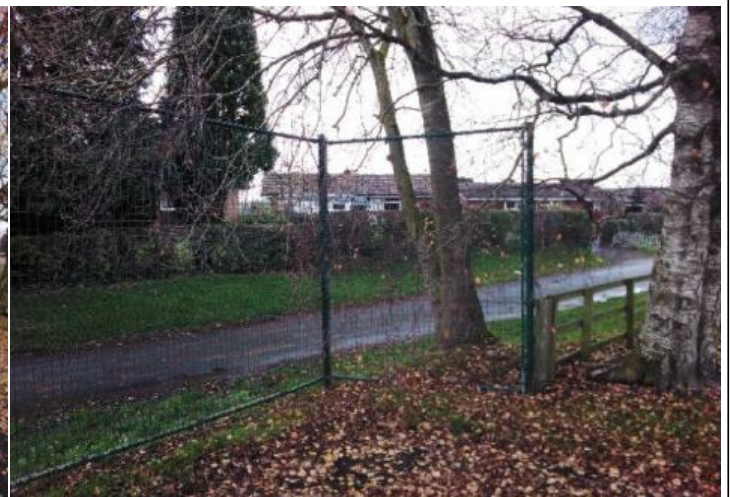
**Item:** Multi Use Games Area - Basketball Post  
**Manufacturer:** Unknown

**Finding:** Tree foliage is hanging into the basket ball area

**Action:** Cut back foliage

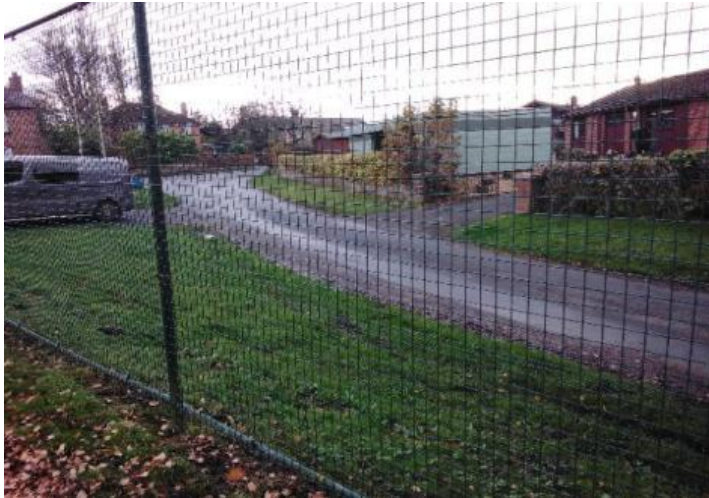
**Item:** Ancillary Items - Fence - Steel Mesh  
**Manufacturer:** Owner/Operator

**Finding:** The fence mesh is loose on the posts in areas

**Action:** Re secure fence to posts

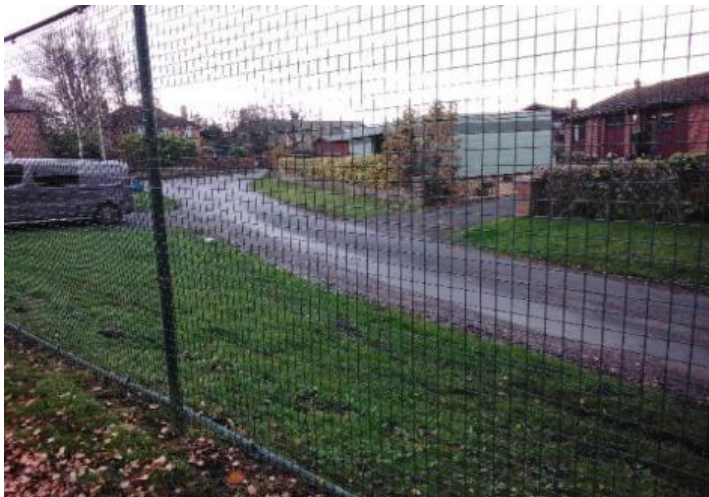
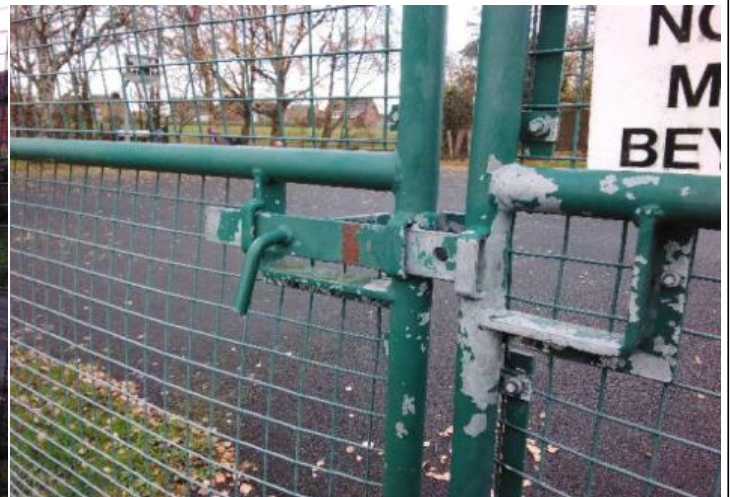
**Item:** Ancillary Items - Fence - Steel Mesh  
**Manufacturer:** Owner/Operator

**Finding:** There is no padlock on the maintenance gate

**Action:** Provide a padlock to secure the gate
